3-YEAR ASBESTOS RE-INSPECTION REPORT

WILLIAM PRESCOTT ELEMENTARY SCHOOL SCRANTON, PA

PROJECT: #SSD.19_751

July 2019

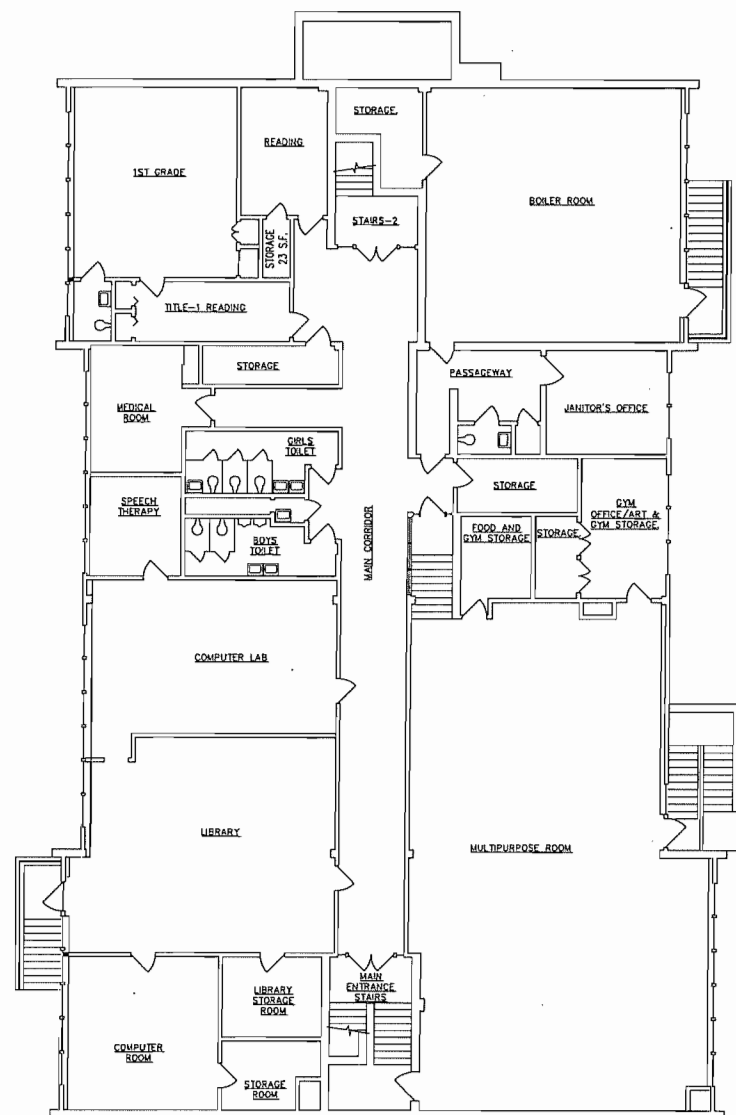
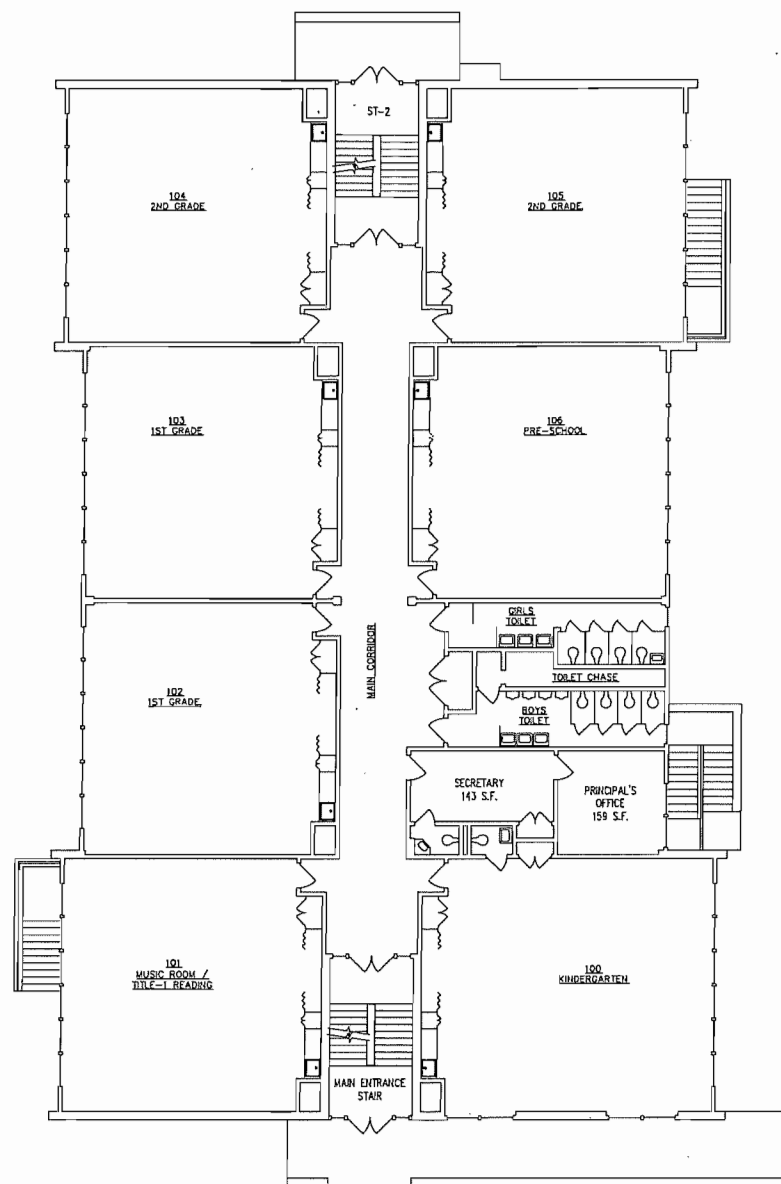
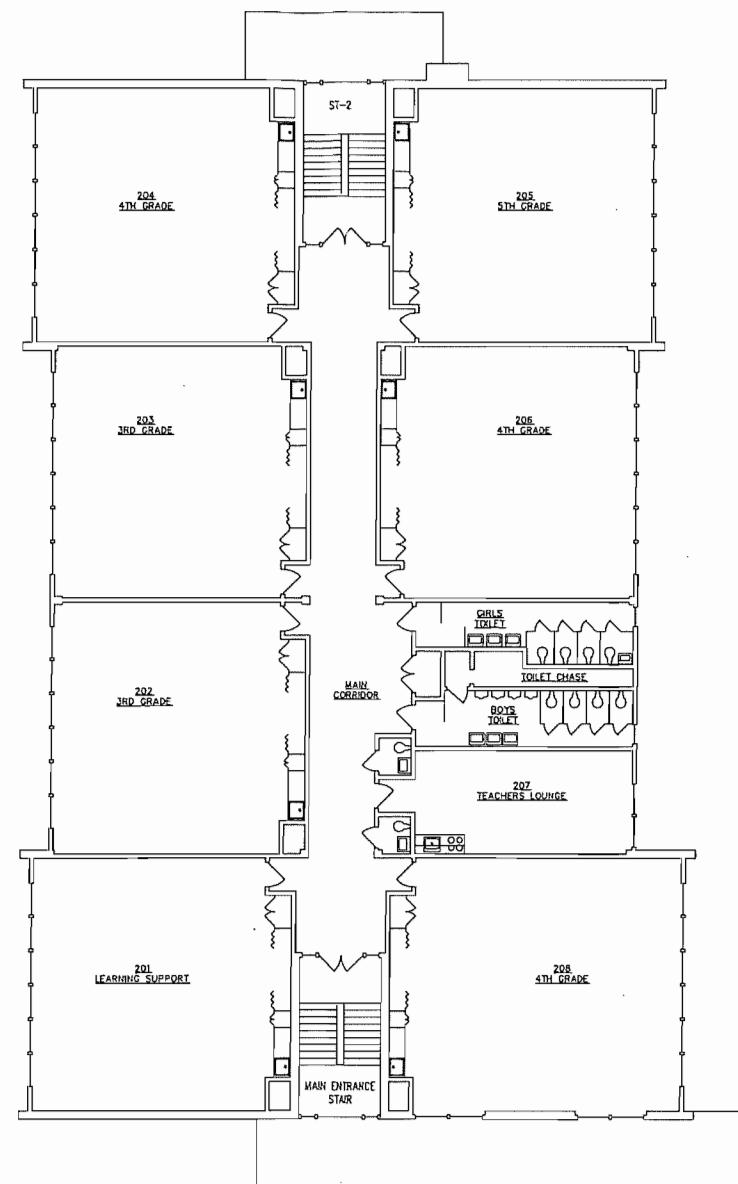
DRAWING No.:
A
 1

KEY - SURFACING ACM
 ASSUMED ASBESTOS CONTAINING SURFACING MATERIALS:
 1. EXTERIOR COATING OF EXISTING SINKS

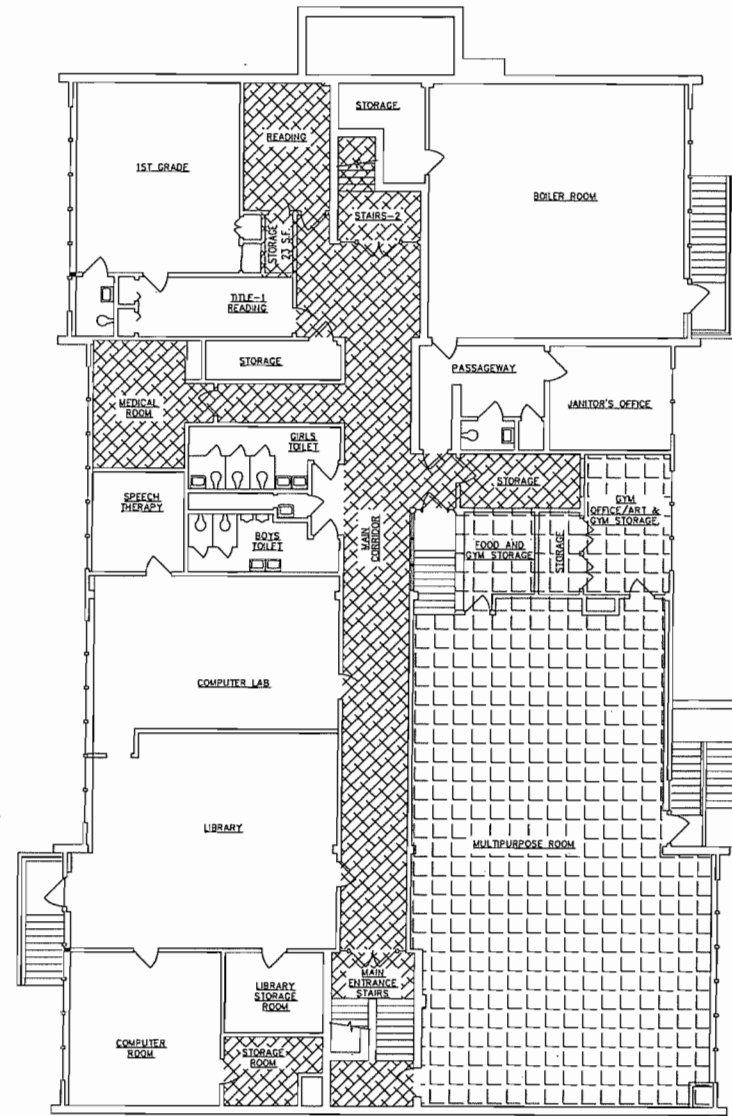
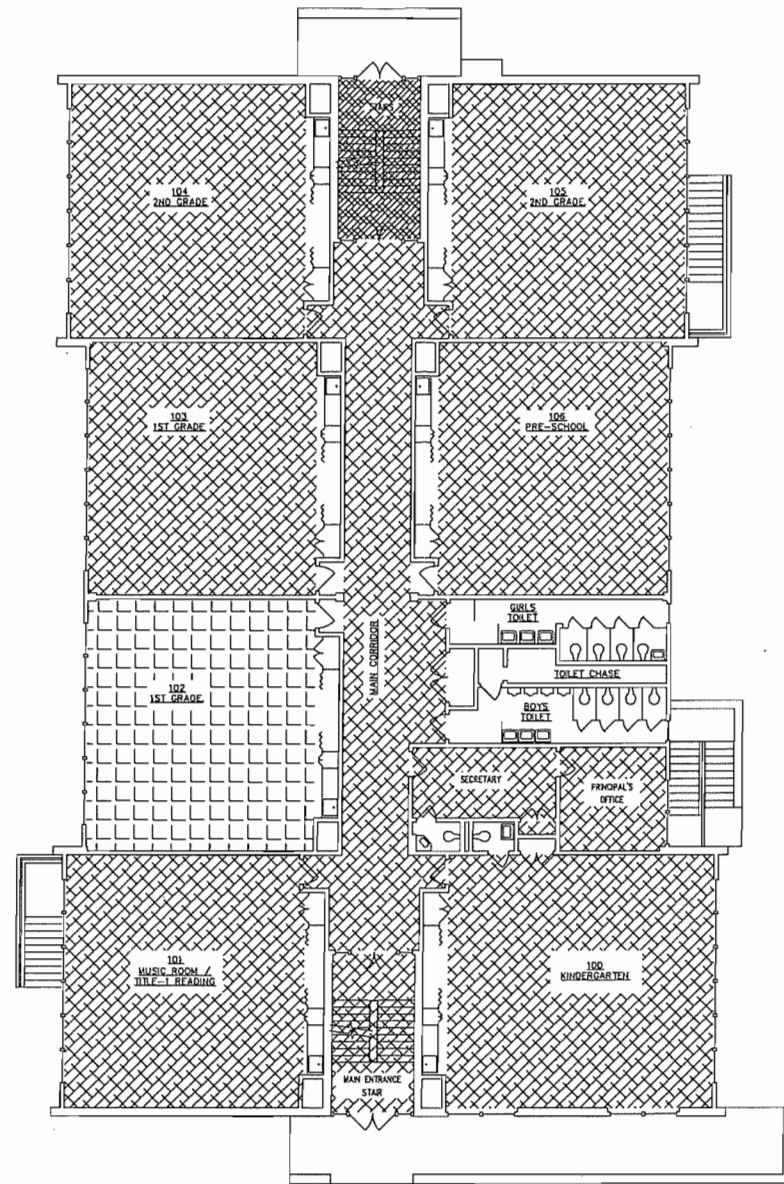
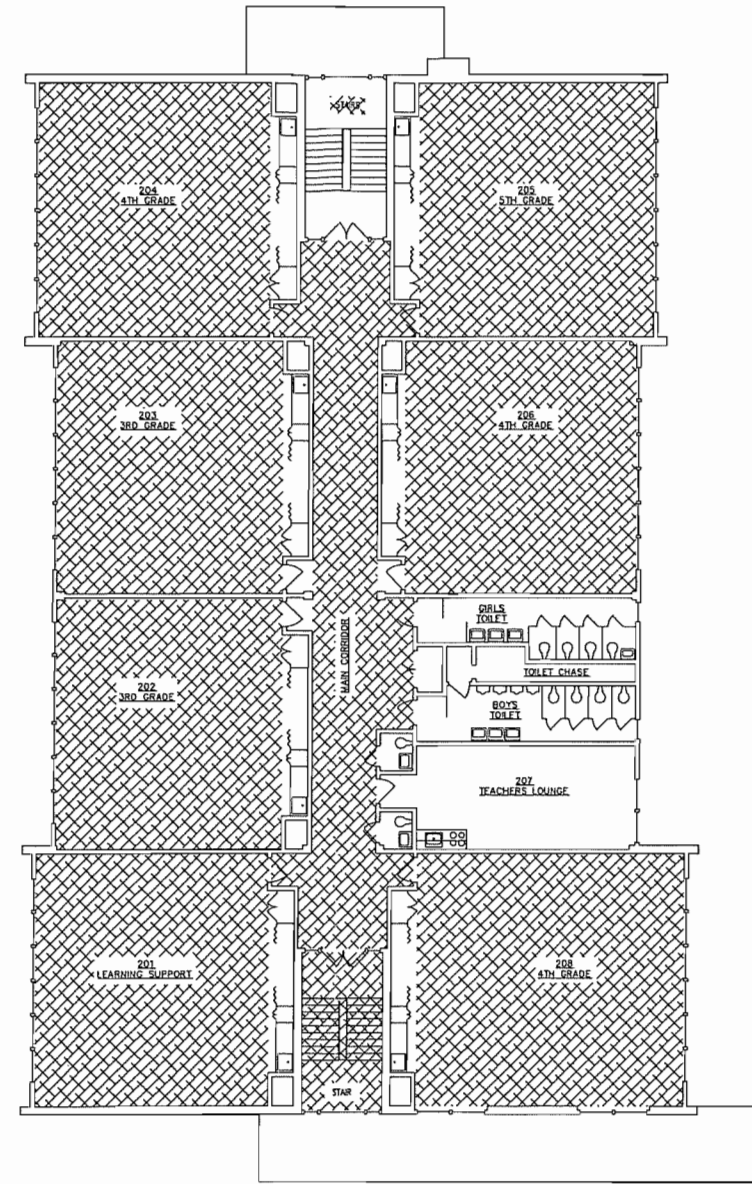
DRAWING No.:
A3

1. ALL MASTIC UNDER ALUMINUM WINDOW FRAMES
2. CHALKING BETWEEN GREEN PANELS
3. DUCTWORK FLEX CONNECTIONS
4. EXTERIOR WINDOW GLAZING
5. DOOR FRAME CAULKING
6. EXPANSION JOINTS
7. CHALKBOARD MASTIC
8. VAPOR BARRIERS (MAY BE PRESENT)

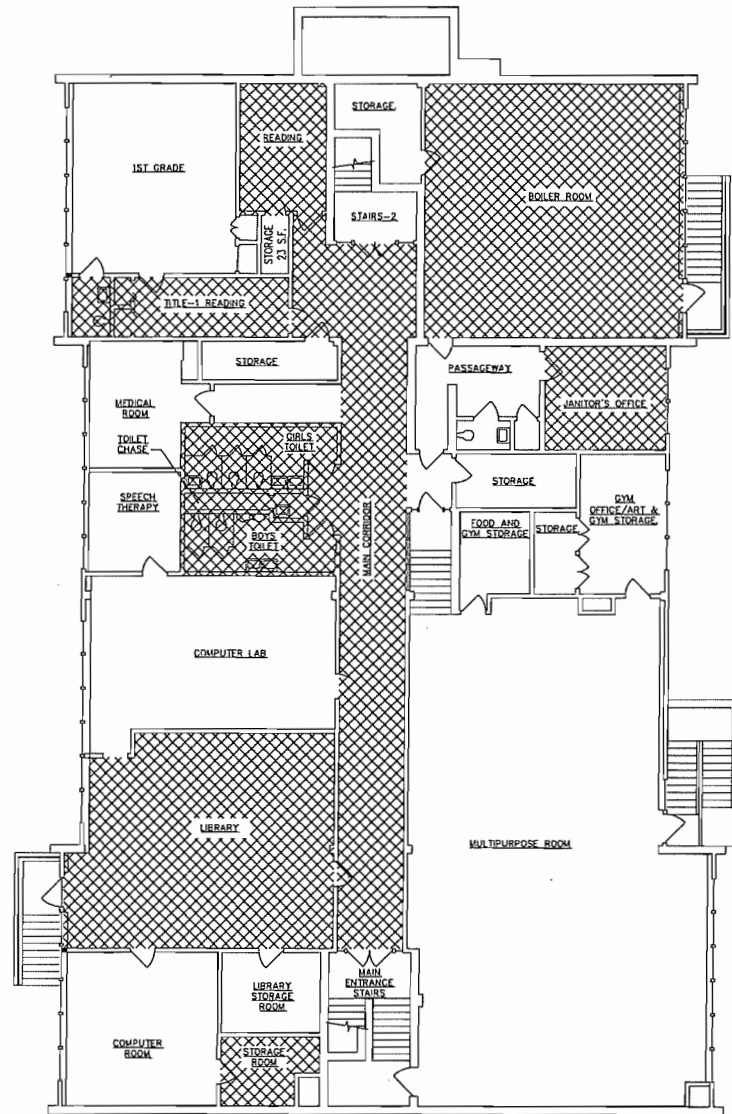
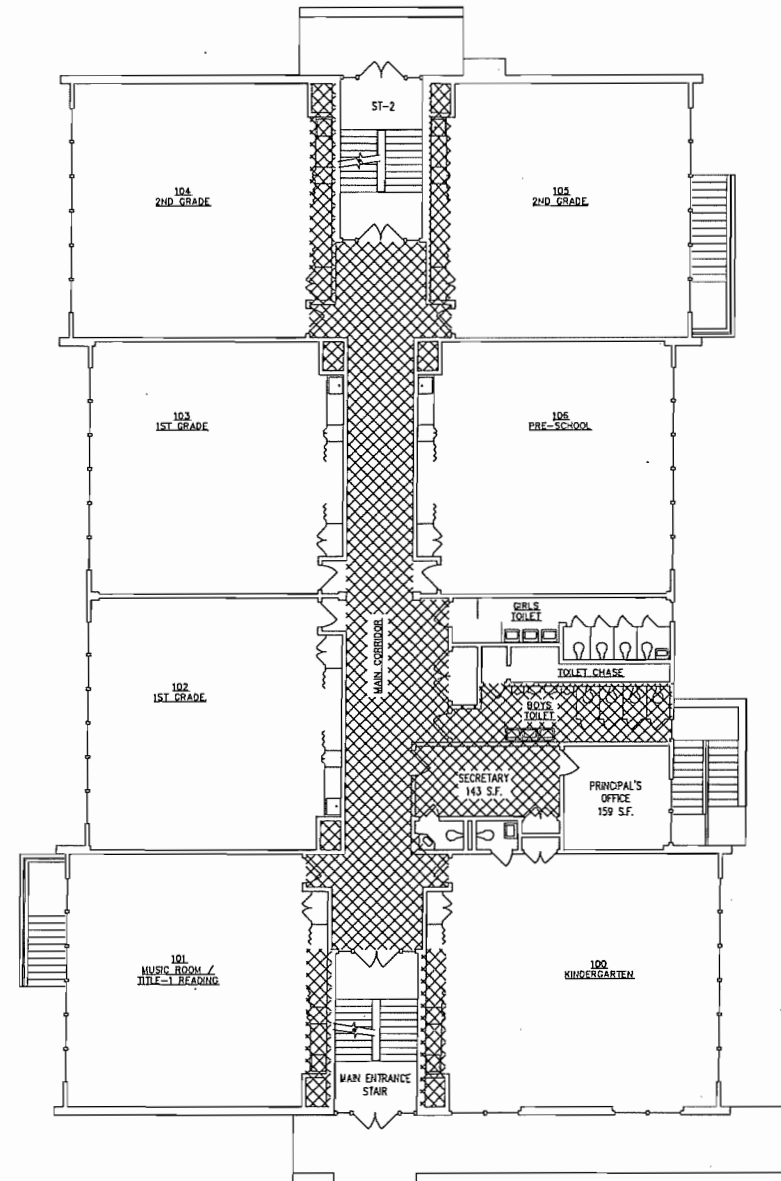
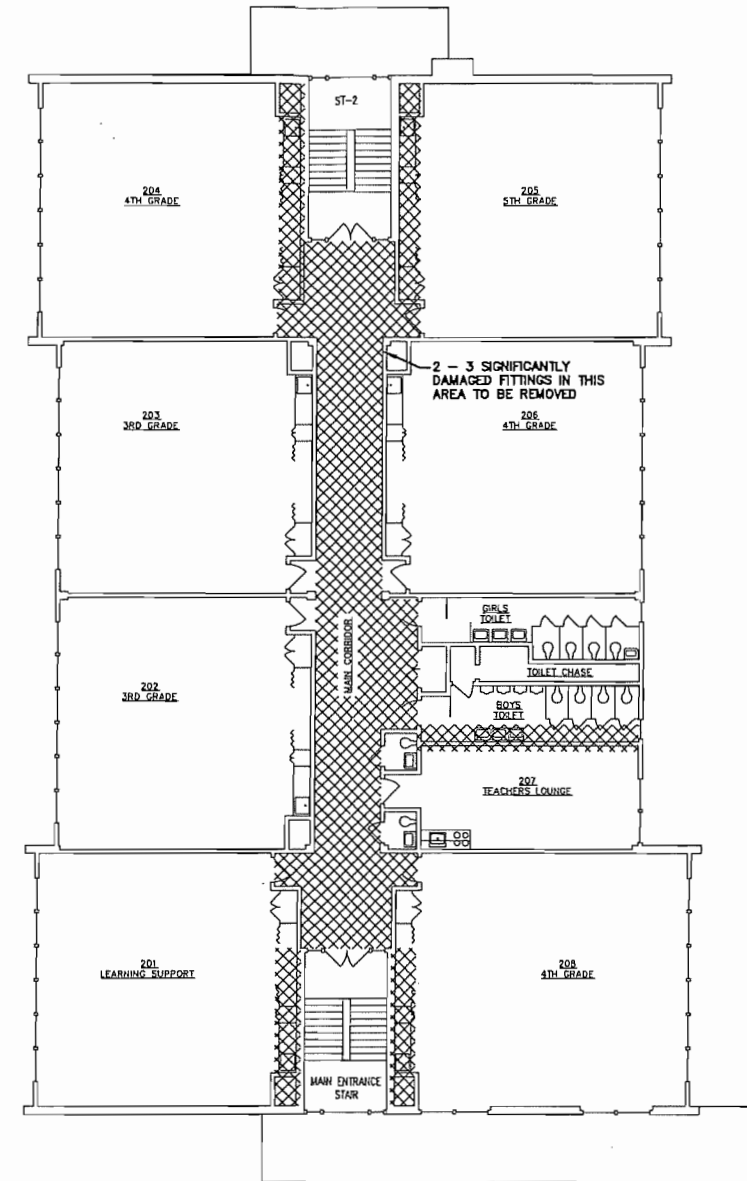
DRAWING No.:
A
2

NOTE: ASSUME FITTINGS ARE LOCATED IN WALLS BEHIND SINKS
