HAMPDEN-WILBRAHAM REGIONAL SCHOOL DISTRICT
EXISTING CONDITIONS and FEASIBILITY STUDY
THORTON W. BURGESS and WILBRAHAM MIDDLE SCHOOL

WILBRAHAM MIDDLE SCHOOL

Hampden-Wilbraham Regional School District
Middle School Study ~ 2 September 2015

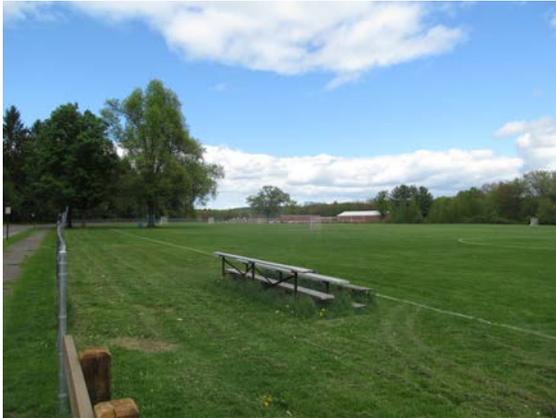
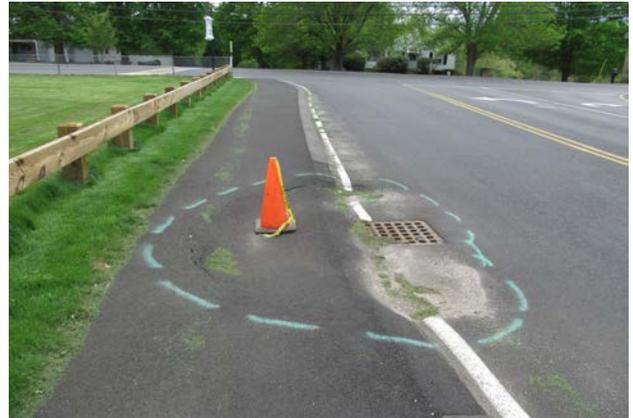
The existing Middle School access drive and parking areas are original to the site and are in very poor condition, with significant areas of deteriorated, damaged and/or missing asphalt paving and curbs.

If the status of WMS is maintained as a single middle school serving the Town of Wilbraham, the existing asphalt access drive except the newly widened area at Stony Hill Road, parking lot and curbing, and storm drainage structures are deteriorated beyond repair and should be removed and replaced in their entirety as budgets allow. Existing playfields require minimal repair except for normal wear and tear.

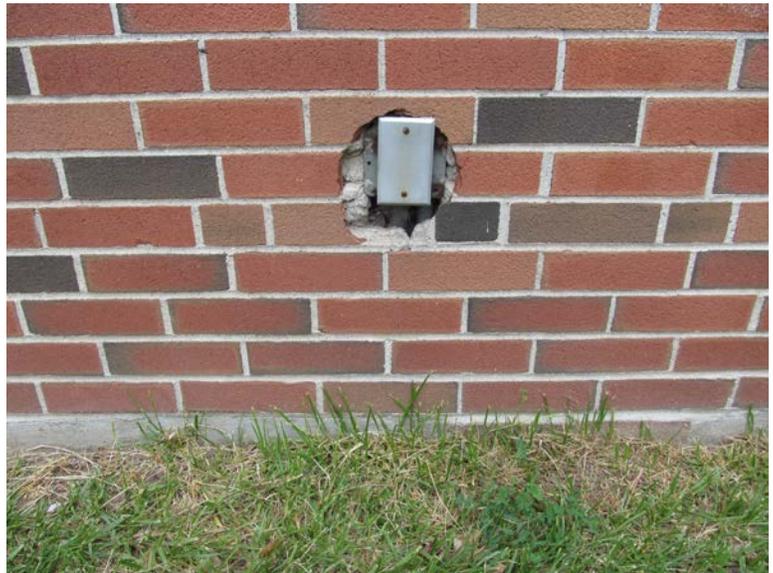
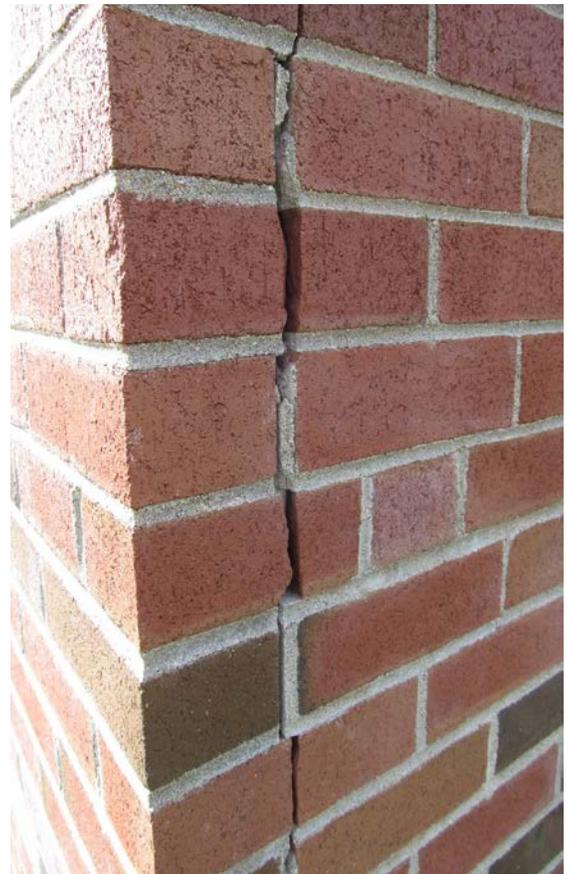
Despite the inherently inefficient nature of wall construction described above, the existing exterior masonry walls are in overall fair condition. However, there exists a note worthy lack of masonry control joints around the building perimeter which when combined with the lack of an internal wall cavity and internal flashing preventing entrapped moisture from being redirected to the exterior, numerous areas of spalling, cracking, and efflorescence on the exterior face are evident. Cracks in the face brick are open to the elements allowing water infiltration. Also, due to no wall insulation, during periods of cold outside temperatures the dew point is located at an undetermined point within the existing masonry, causing condensation to occur within the masonry wall. These are inherent systemic problems which will continue to occur and can result in long-term deterioration of the exterior masonry walls. In addition, though the thermal mass of the existing exterior walls acts to moderate outside air temperature extremes, the lack of exterior wall insulation fails to comply with current building and energy code requirements.

If the status of WMS is maintained as a single middle school serving the Town of Wilbraham, selected areas of existing exterior masonry should be repaired or replaced to correct current continuing deficiencies and minimize future masonry deterioration as budgets allow.

- All exterior walls be insulated at the interior face to maximize energy efficiency
- New masonry exterior control joints be installed around the entire building perimeter in accordance with current accepted building standards.
- The existing masonry chimney be repaired, repointed, and recaulked in its' entirety

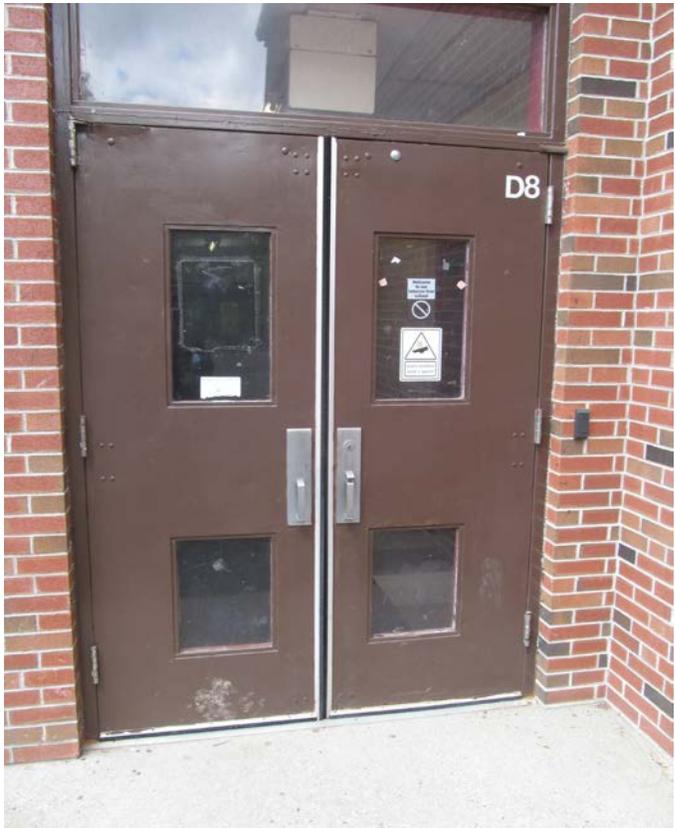
Exterior entrances are in poor condition with varying degrees of missing and/or damaged operating hardware and deteriorated weatherstripping. The large majority of exterior doors are too narrow and do not meet current accessibility requirements. Exterior windows are in fair to poor condition with minimal insulating value and selected units with non-functioning operating hardware.

If the status of WMS is maintained as a single middle school serving the Town of Wilbraham, selected existing exterior doors should be repaired or replaced to correct current continuing deficiencies and provide safe and secure building access and egress as budgets allow.

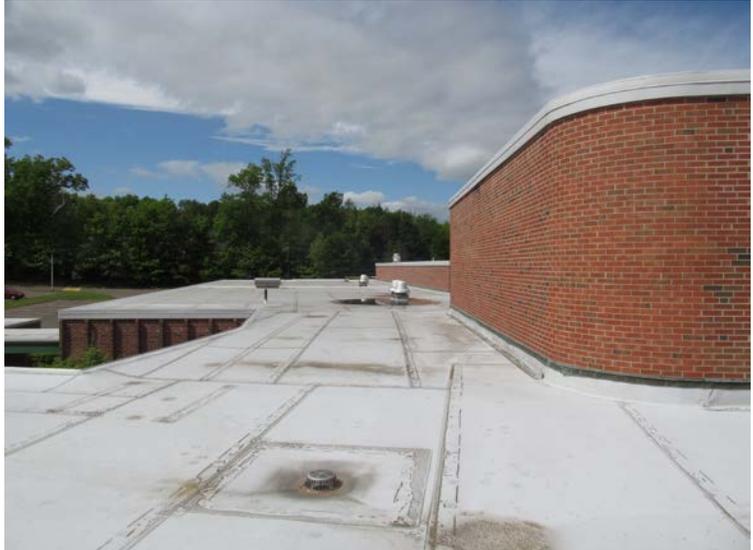
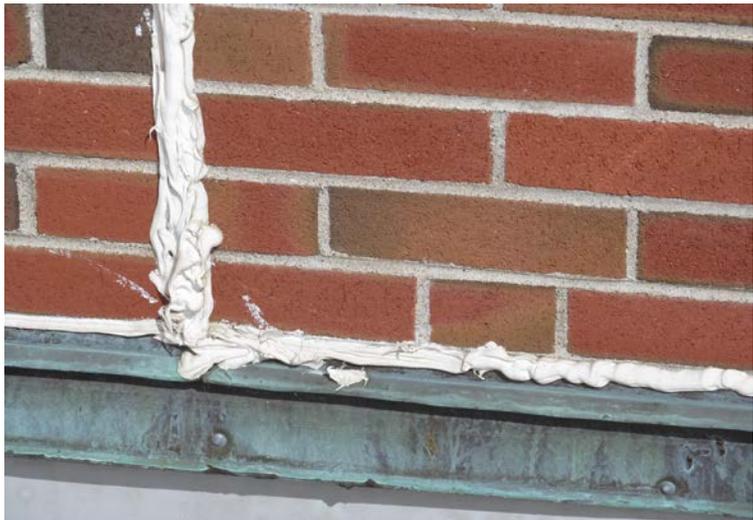
The existing roof membrane is in fair condition with selected areas of deteriorated seams, ponding water, and missing or poorly installed roof-to-wall flashing. While adequate, existing roof drain locations serve greater than the currently recommended roof area.

If the status of WMS is maintained as a single middle school serving the Town of Wilbraham, selected damaged areas of the existing roofing and flashing and visibly damaged or missing roof system components should be professionally repaired or replaced to correct current continuing leaking into the building, with resulting negative impact on indoor air quality (IAQ), as budgets allow.

- Removal and replacement of existing roofing insulation, single ply membrane, flashing and accessories in their entirety, and installation of new
- Installation of additional roof drains with overflow capability in accordance with current plumbing code requirements.

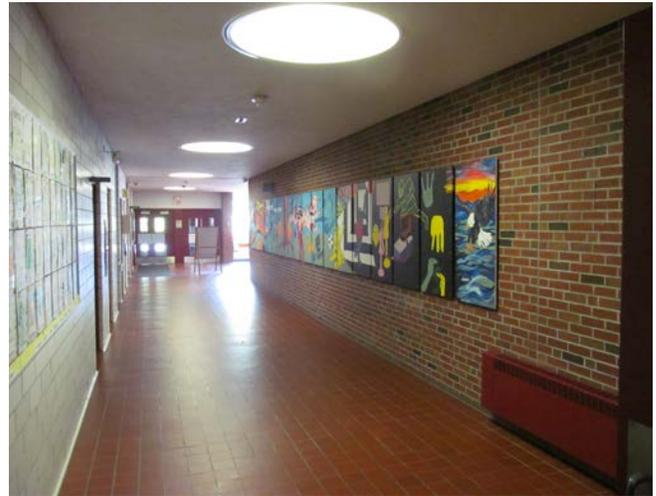
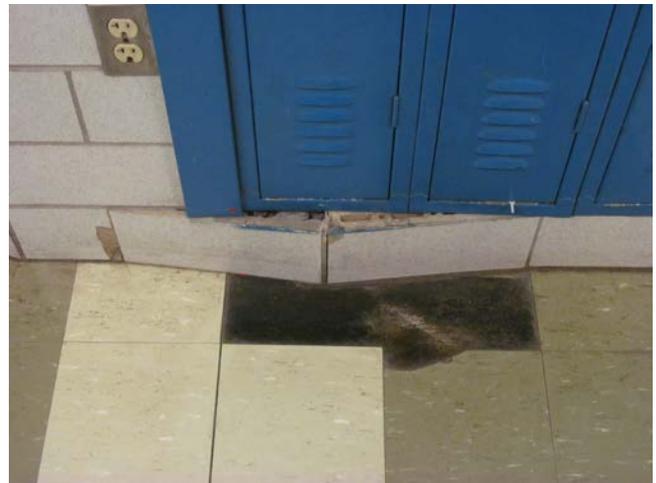
Interior walls throughout the existing building are in overall fair condition, with several selected areas of significant cracking of concrete block and structural glazed tile due to differential expansion rates between structural glazed tile and concrete block back-up, combined with the noteworthy lack of adequate masonry control joints. Also, due to the age of the existing building masonry walls are not designed for current building code seismic requirements.

If the status of WMS is maintained as a single middle school serving the Town of Wilbraham, selected damaged areas of existing interior walls should be professionally repaired, as budgets allow.

- New interior masonry control joints be installed in accordance with current accepted building standards.
- Modification of interior partitions to address educational program deficiencies
- Compliance with current seismic code requirements.

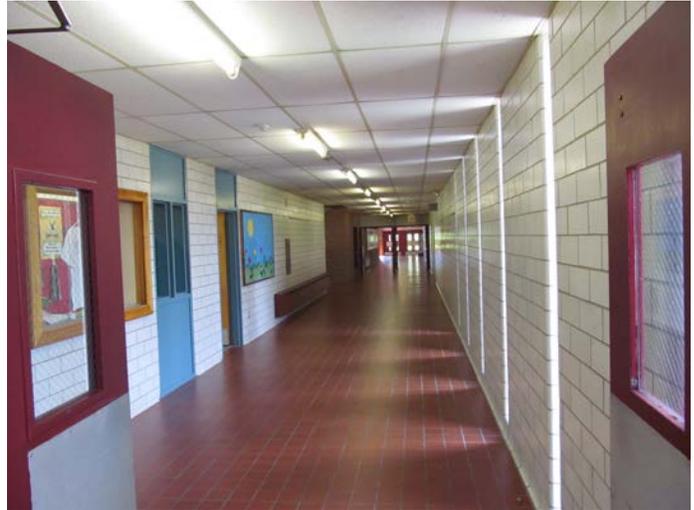
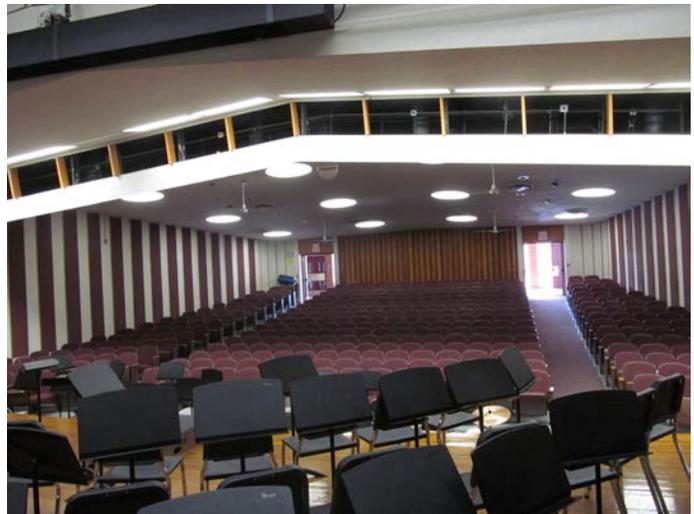
Existing ceilings located throughout the building are in overall fair to good condition with selected individual areas exhibiting damaged or missing components.

If the status of WMS is maintained as a single middle school serving the Town of Wilbraham, selected damaged areas of existing ceilings could be repaired on an as needed basis following completion of roof repairs described above, as budgets allow, *except*, existing water damaged ceilings should be removed immediately, the source of water infiltration repaired, and ceilings replaced to improve indoor air quality (IAQ).

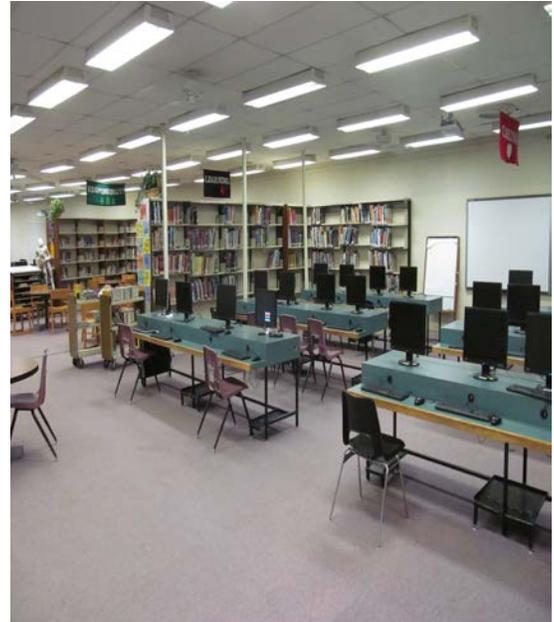
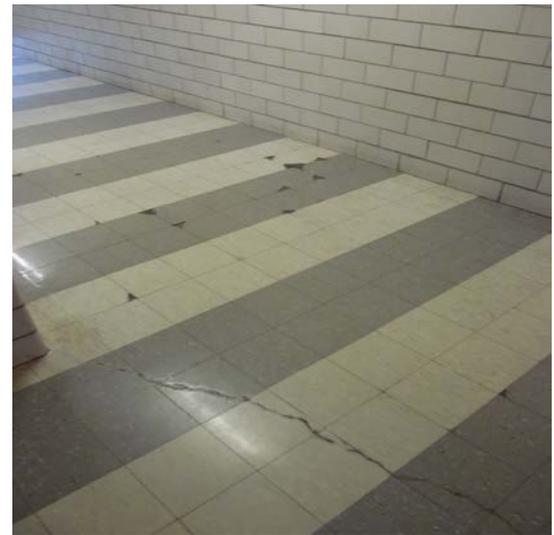
With limited exceptions, existing floor finishes throughout the existing building are in fair to poor condition, exhibiting varying degrees of deterioration beyond what could be considered normal wear and tear.

If the status of WMS is maintained as a single middle school serving the Town of Wilbraham, selected damaged areas of existing flooring could be repaired on an as needed basis following completion of roof repairs described above, as budgets allow, *except*, existing water damaged flooring and accessories should be removed immediately, the source of water infiltration repaired, and materials replaced to improve indoor air quality (IAQ).

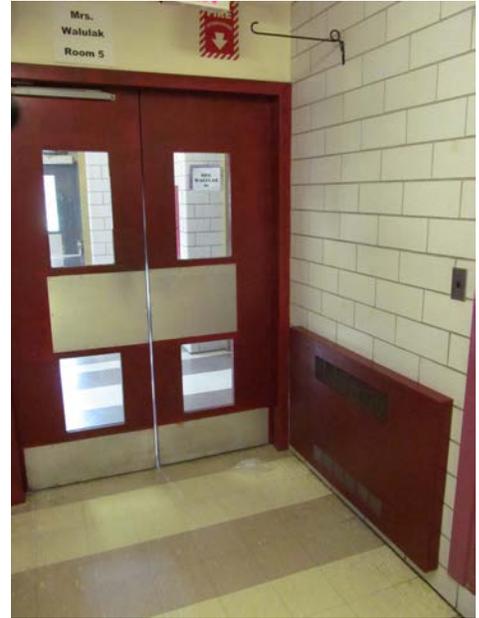
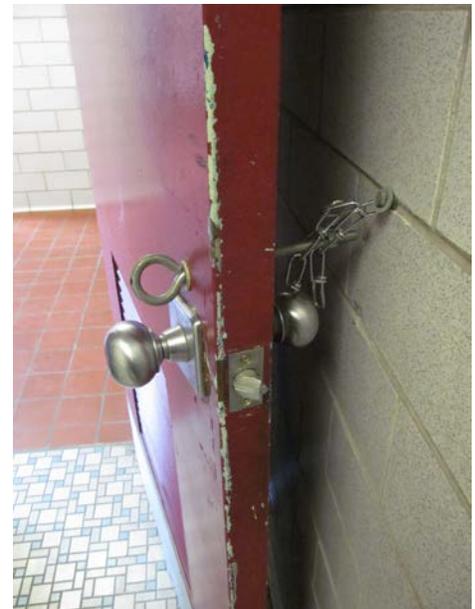
All interior doors throughout the building are in fair to poor condition, exhibiting varying degrees of functional and operational deficiencies, including damaged, missing, or obsolete hardware. The large majority of existing doors and selected door openings throughout the building are narrower than required to meet current handicapped code requirements.

If the status of WMS is maintained as a single middle school serving the Town of Wilbraham, selected damaged doors could be replaced on an as needed basis and selected doors removed and replaced to better comply with current ADA, MAAB, and Building code requirements.

- Remove and replace all existing interior doors and operating hardware in their entirety, including selected wall removal, wall door openings relocated or enlarged with new frames, doors and hardware to comply with current ADA, MAAB, and Building code. As part of any proposed future addition/renovation, all existing interior doors and hardware must be replaced, and in a number of locations frames and doors must be removed in their entirety, wall openings enlarged, and new frames, doors and hardware installed as required to comply with current ADA, MAAB, and Building code requirements.

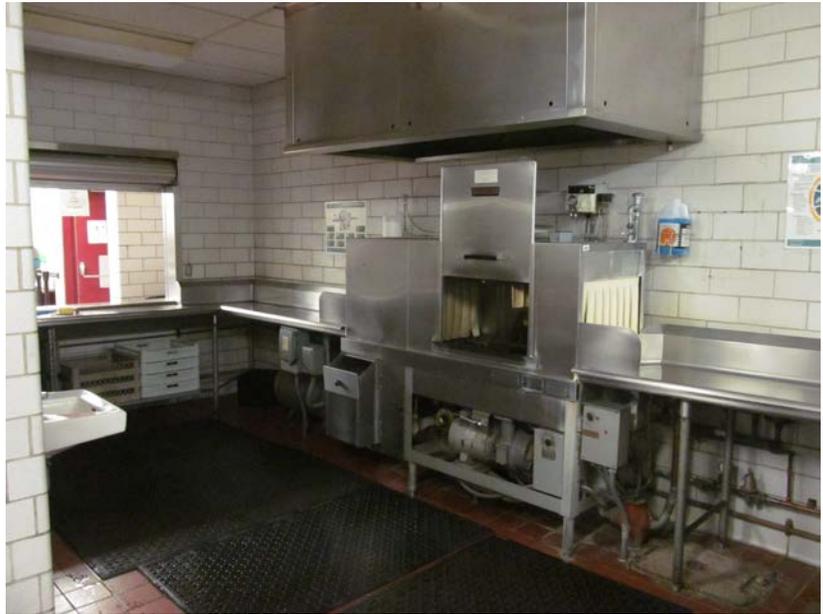
The existing food service equipment is in overall fair condition, well maintained, and subject to ongoing repairs and replacement. See Part C3 of this Report for detailed evaluation of the kitchen exhaust hood, and related mechanical, plumbing, electrical and life safety systems.

- Existing food service equipment will be removed and replaced on an individual, as needed basis
- See Part C3 of this Report for detailed evaluation of the kitchen exhaust hood, and related mechanical, plumbing, electrical and life safety systems.

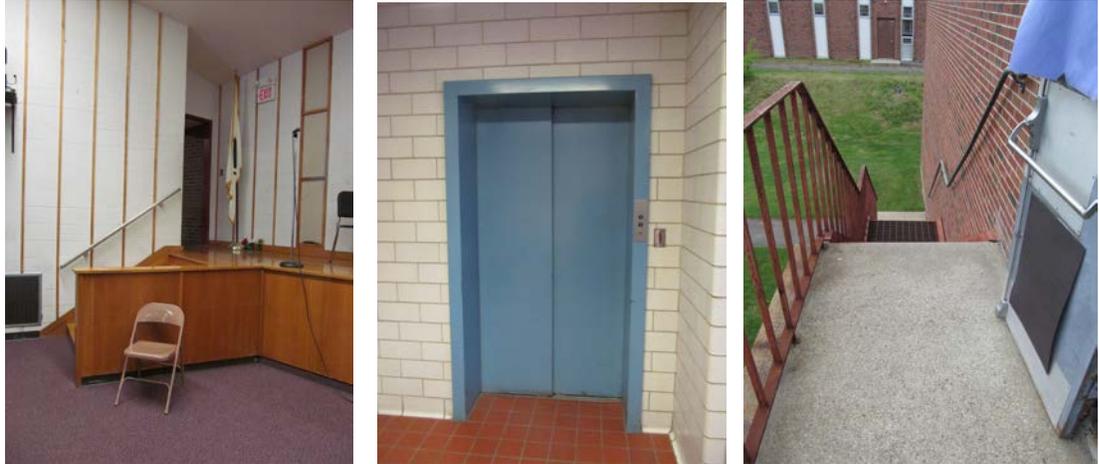
With the exception at one (1) pair of main entry doors and selected student toilet room doors, numerous locations throughout the existing building restrict handicapped accessibility, including but not limited to, all exterior and interior doors, Auditorium Stage, elevator and two-story classroom wing north and south metal fire escapes that fail to comply with current ADA, MAAB, and Building Code accessibility requirements.

- Remove and replace existing interior doors and operating hardware in their entirety, including selected wall removal, wall door openings relocated or enlarged with new frames, doors and hardware
- New vertical circulation (ramp or chairlift at Auditorium Stage)
- Replacement of elevator controls
- See Part C3 of this Report for detailed evaluation of related mechanical, plumbing, electrical and life safety systems.

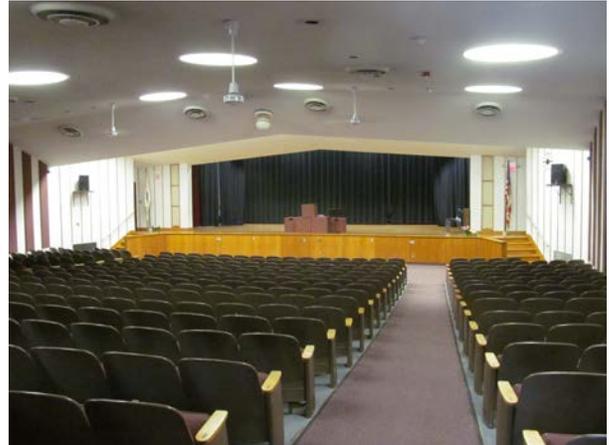
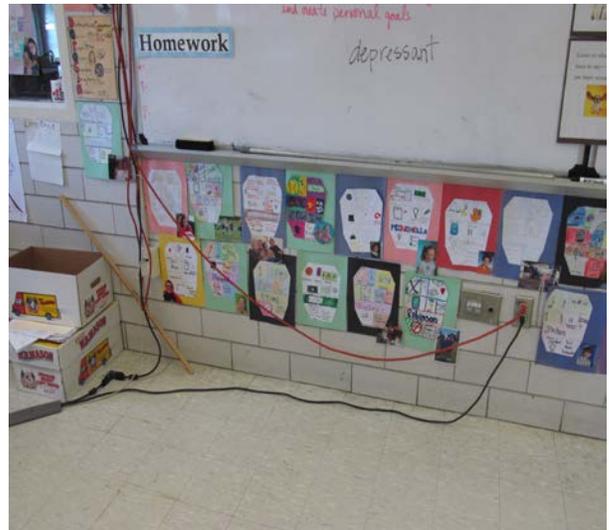
While generally useable, existing miscellaneous equipment throughout the building is in fair to poor condition, exhibiting varying degrees of deterioration beyond what could be considered normal wear and tear. with selected locations failing to comply with current ADA, MAAB and Building Code requirements. Ironically, while the technology system serves the school well, the existing electrical system is at if not over, its original design capacity. See the Mechanical Section of this Report for detailed evaluation of related mechanical, plumbing, electrical and life safety systems.

- Replacement of existing miscellaneous equipment to provide effective operation of an efficient, modern and educationally sound middle school
