HAMPDEN-WILBRAHAM REGIONAL SCHOOL DISTRICT
EXISTING CONDITIONS and FEASIBILITY STUDY
THORNTON W. BURGESS and WILBRAHAM MIDDLE SCHOOL

THORNTON W. BURGESS MIDDLE SCHOOL

SITE EVALUATION

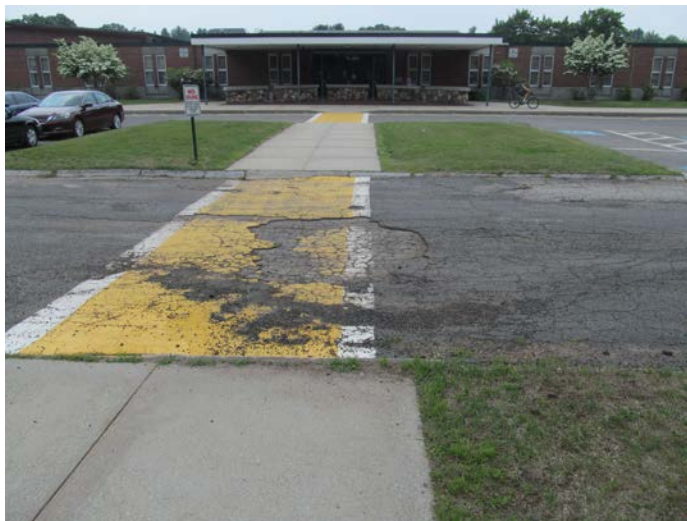
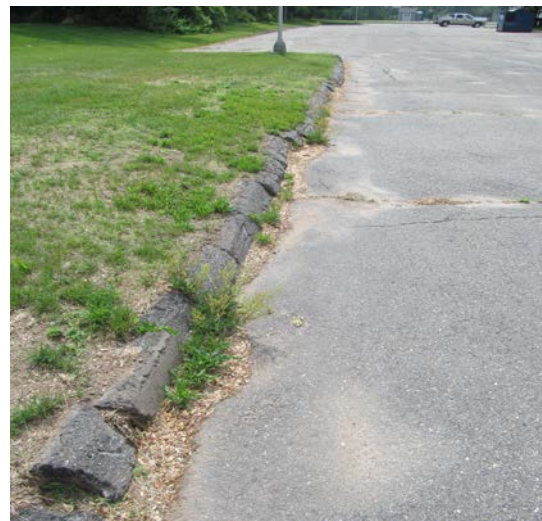
The existing Middle School access drive and parking areas are original to the site and are in very poor condition, with significant areas of deteriorated, damaged and/or missing asphalt paving and curbs. Athletic and play fields behind the building are in good condition with minimal evidence of deterioration.

Renovation: If the status of TWB is maintained as a single middle school serving the Town of Hampden, the existing asphalt access drive, parking lot and curbing, are deteriorated beyond repair and should be removed and replaced in their entirety as budgets allow. Existing playfields require minimal repair except for normal wear and tear.

- Removal and replacement of all existing asphalt paved areas and curbing, traffic circulation and parking, including increased parking capacity to serve increased student and staff population.
- See Part B – Building Evaluation and Part C - Mechanical System Evaluations of this Report for detailed evaluation and recommendations for existing building architectural systems.

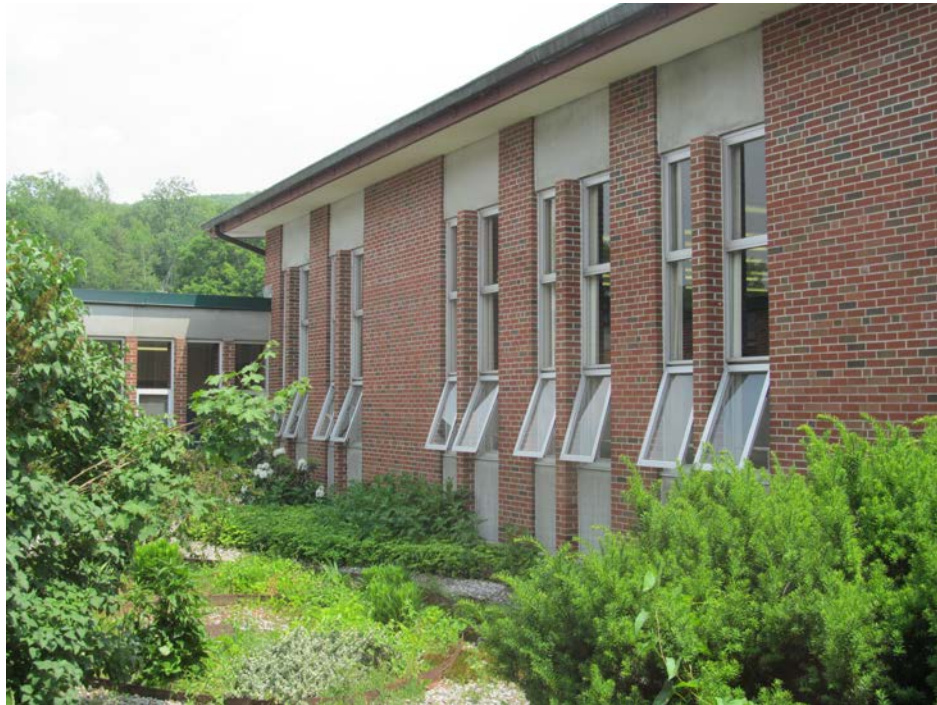
Despite the inherently inefficient nature of the type of wall construction described above, the existing exterior masonry walls are in overall good condition. However, there exists a noteworthy lack of masonry control joints around the building perimeter which when combined with the lack of an internal wall cavity and internal flashing preventing entrapped moisture from being redirected to the exterior, several areas of spalling, cracking, and efflorescence on the exterior face are evident. Also, due to no wall insulation, during periods of cold outside temperatures the dew point is located at an undetermined point within the existing masonry, causing condensation to occur within the masonry wall. These are inherent systemic problems which will continue to occur and can result in long-term deterioration of the exterior masonry walls. In addition, though the thermal mass of the existing exterior walls acts to moderate outside air temperature extremes to a limited degree, the lack of exterior wall insulation does not comply with current building and energy code requirements.

Renovation If the status of TWB is maintained as a single middle school serving the Town of Hampden, selected areas of existing exterior masonry should be repaired or replaced to correct current ongoing and minimize future masonry deterioration as budgets allow.

- All exterior walls be insulated at the interior face to maximize energy efficiency
- New masonry control joints be installed around the entire building perimeter in accordance with current accepted building standards.
- The existing masonry chimney be removed and replaced in its' entirety

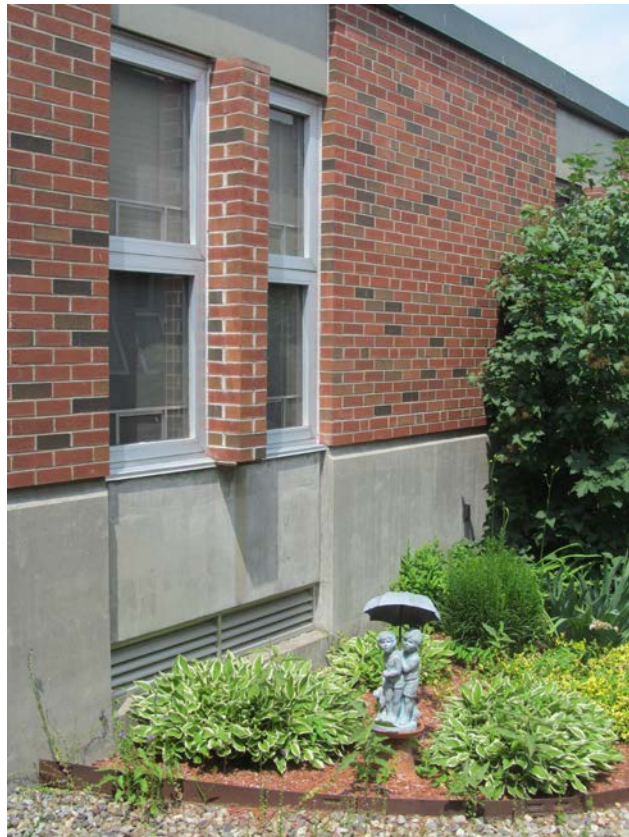
Exterior entrance doors are in overall fair condition with varying degrees of missing and/or damaged operating hardware. Exterior windows are in fair to poor condition with barely minimal insulating value, deteriorated weatherstripping and selected units with non-functioning operational and locking hardware. The large majority of existing exterior doors throughout the building are narrower than required to meet current handicapped code requirements.

If the status of TWB is maintained as a single middle school serving the Town of Hampden, selected exterior doors could be removed and replaced in their entirety to provide new insulated hollow metal doors and operational hardware with increased energy efficiency, security and handicapped accessibility, as budgets allow.

- All exterior doors be removed and replaced in their entirety to provide new insulated hollow metal doors and operational hardware with maximized energy efficiency, security and handicapped accessibility
- New masonry control joints be installed around the entire building perimeter in accordance with current accepted building standards.
- The existing masonry chimney be removed and replaced in its' entirety

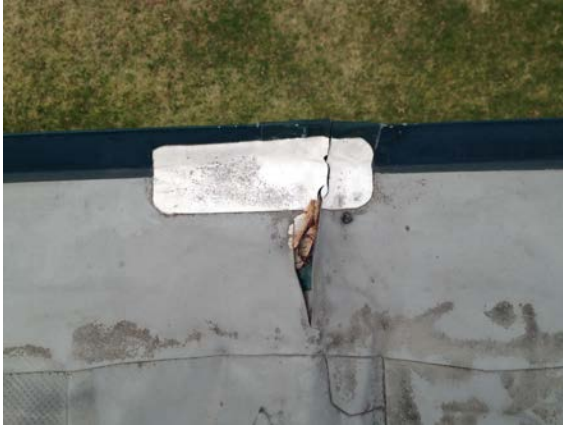
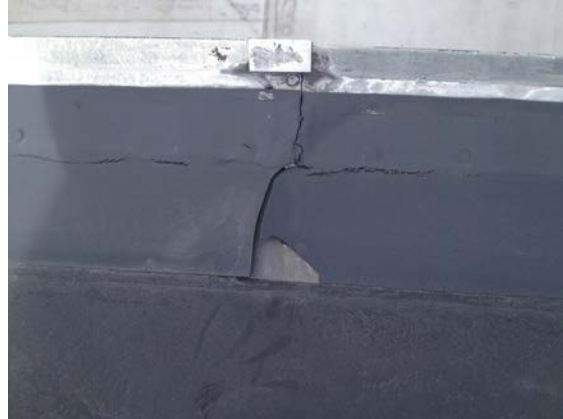
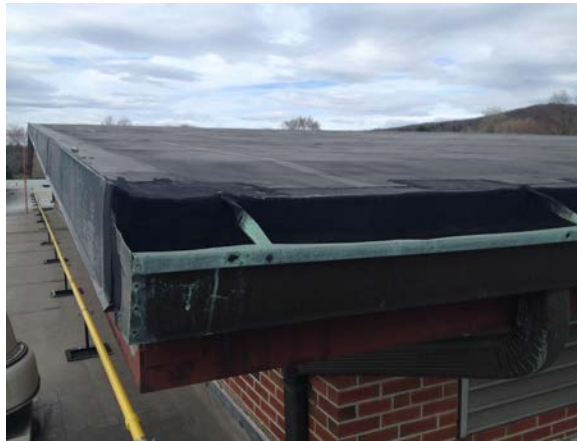
Both existing roof membranes are in poor condition with numerous areas of deteriorated seams, ponding water at various locations, missing or poorly installed roof-to-wall flashing, and evidence of water saturated insulation below the membranes. While adequate, existing roof drain locations serve greater than the currently recommended roof area. Copper gutters are deteriorated and leaking and have reached the end of their expected life span

Given the age and overall condition of the existing roof and its related accessories, and regardless of the future status of TWB, either as a single middle school serving the Town of Hampden, or as a consolidated middle school serving the Towns of Hampden and Wilbraham, the following minimum building system replacement must be undertaken immediately:

- The entire existing roof systems be removed and replaced in its entirety, including replacement of concealed steel roof deck found to be damaged upon roof system removal and installation of additional roof drains with overflow capability in accordance with current plumbing code requirements to maximize energy efficiency, eliminate moisture penetration into the building and improve air quality by elimination of water saturated roof insulation.

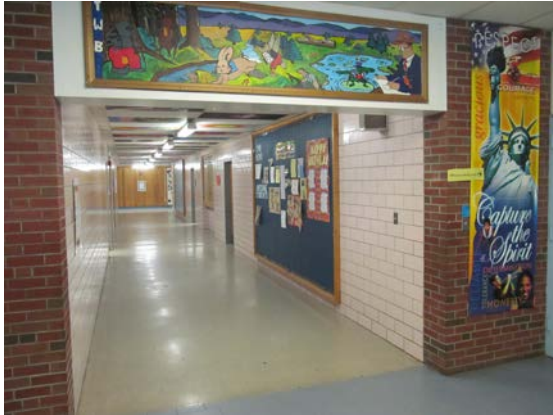
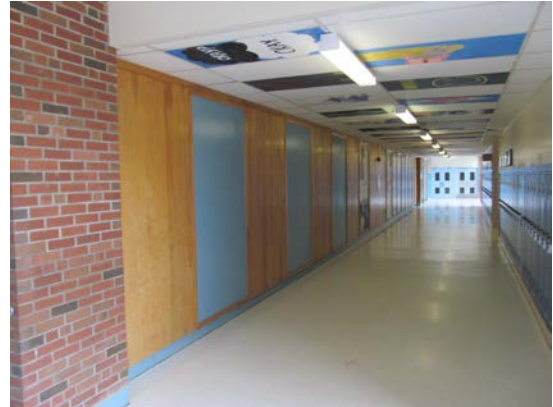
Interior walls throughout the existing building are in overall good condition, with selected areas of visible damage to concrete block and structural glazed tile due to differential expansion between structural glazed tile and concrete block back-up, and limited masonry crack control joints and expansion joints. Also, due to the age of the existing building masonry walls are not designed to meet current building code seismic requirements.

If the status of TWB is maintained as a single middle school serving the Town of Hampden, selected areas of visible damage to concrete block and structural glazed tile could be repaired or replaced, as budgets allow.

- Removal and replacement of interior masonry wall as required to best serve educational program
- Reinforcement and bracing of all new and existing interior masonry walls as required to meet current building code seismic requirements
- Installation of new masonry control joint in accordance with current accepted building standards.

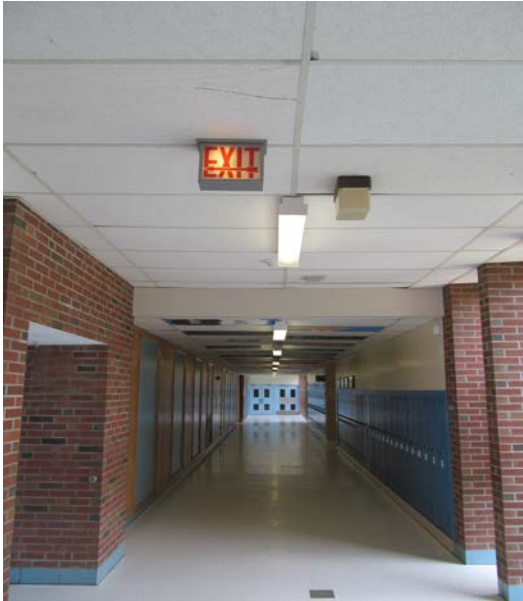
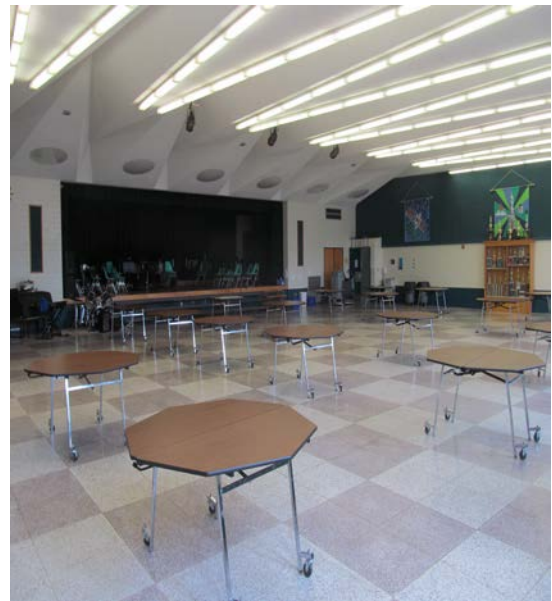
Existing ceilings located throughout the building are in overall fair to good condition with selected individual areas exhibiting damaged or missing components due to mechanical or water damage or normal wear-and-tear.

If the status of TWB is maintained as a single middle school serving the Town of Hampden, selected areas of visibly damaged ceiling tile and plaster could be repaired or replaced, as budgets allow.

- Complete removal and replacement of all existing ceiling systems

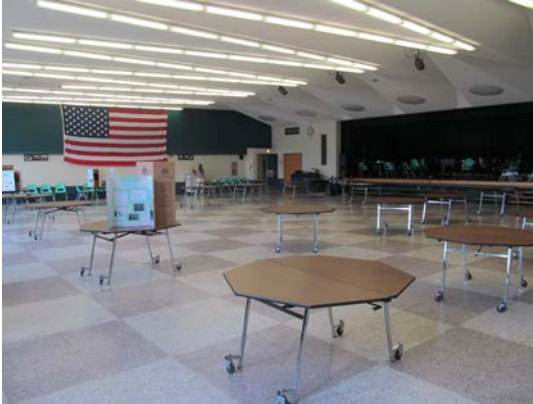
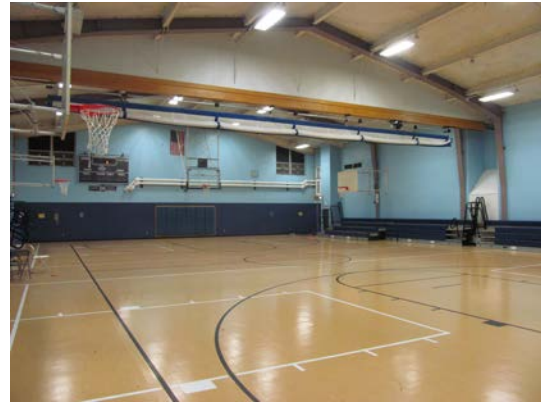
Existing floor finishes throughout the existing building are in fair to good condition, exhibiting varying degrees of deterioration beyond what could be considered normal wear and tear.

If the status of TWB is maintained as a single middle school serving the Town of Hampden, selected areas of visibly damaged VAT and VCT flooring could be repaired or replaced, as budgets allow.

- All existing floor finishes, either be protected-to-remain; or be removed and replaced in their entirety, or in the case of the poured-in-place terrazzo, protected-to-remain and refinished.

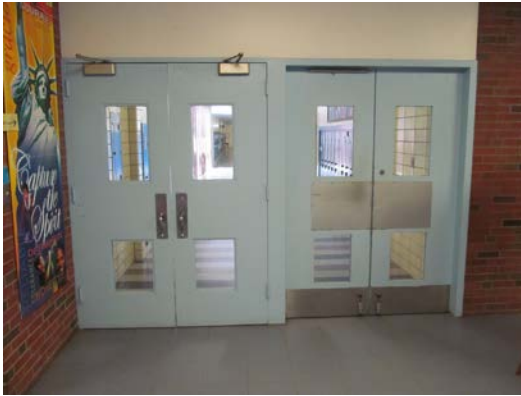
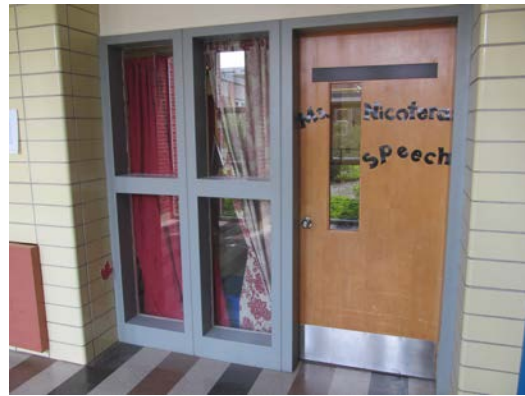
All interior doors throughout the building are in fair to good condition, exhibiting varying degrees of functional and operational deficiencies, including damaged, missing, or obsolete hardware. The large majority of existing doors and selected door openings throughout the building are narrower than required to meet current handicapped code requirements.

If the status of TWB is maintained as a single middle school serving the Town of Hampden, selected interior doors and operating hardware should be removed and replaced, as budgets allow, to better comply with current ADA, MAAB, and Building code requirements. .

- Remove and replace all existing interior doors and operating hardware in their entirety, including selected wall removal, wall door openings relocated or enlarged with new frames, doors and hardware to comply with current ADA, MAAB, and Building code requirements.

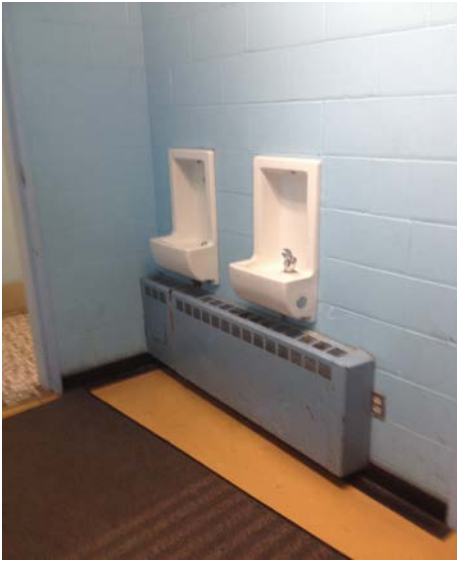
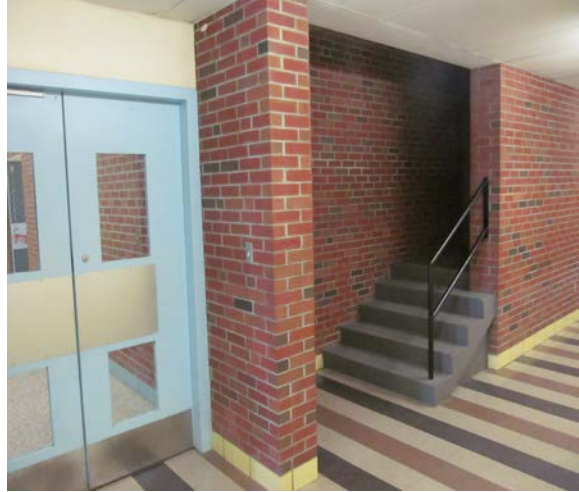
With the exception of one (1) pair of main entry doors and selected toilet rooms, there are numerous locations throughout the building that restrict handicapped accessibility, including all exterior and interior doors and hardware, Cafetorium Stage, drinking fountains, areaways, and toilet rooms that fail to comply with current ADA, MAAB, and Building Code requirements. See the Mechanical Section of this Report for detailed evaluation of related mechanical, plumbing, electrical and life safety systems.

- Complete removal and replacement of all existing deficiencies as required to comply with current ADA, MAAB, and Building Code accessibility requirements; including
 - Wall and door removal and replacement or relocation
 - Plumbing fixture relocation or replacement
 - Vertical circulation (ramp or chairlift at Cafetorium Stage)

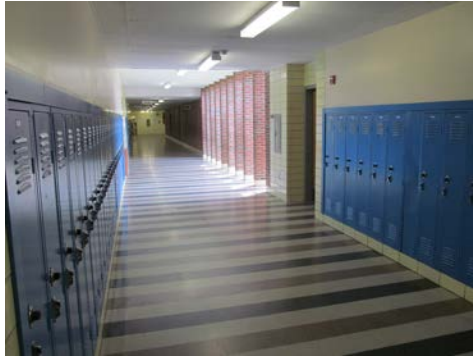
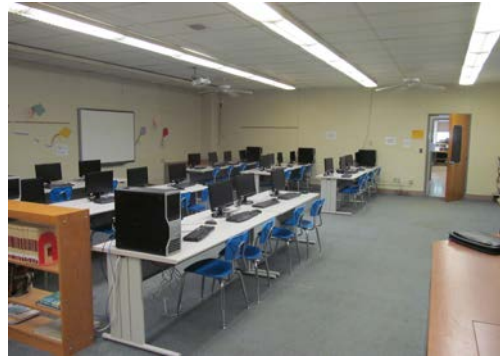
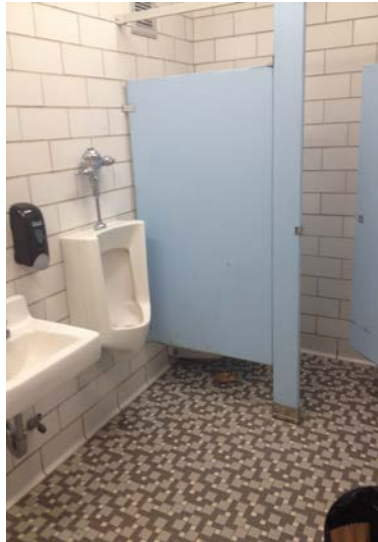
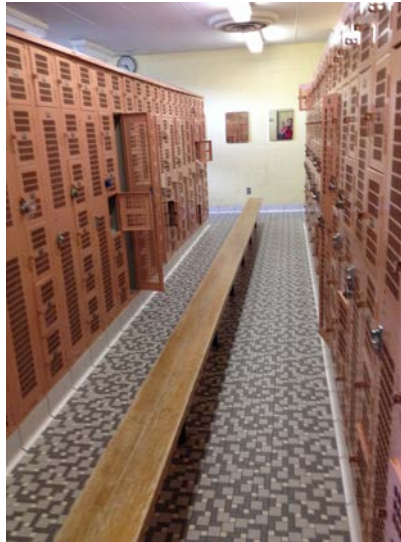
While generally useable, existing miscellaneous equipment throughout the building is in fair to poor condition, exhibiting varying degrees of deterioration beyond what could be considered normal wear and tear; with selected locations failing to comply with current ADA, MAAB and Building Code requirements. Ironically, while the technology system serves the school well, the existing electrical system is at if not over, its original design capacity. See the Mechanical Section of this Report for detailed evaluation of related mechanical, plumbing, electrical and life safety systems.

- Complete removal and replacement of all existing miscellaneous equipment as an integral component of the complete renovation/addition described elsewhere in this Report, and required to increase the student and staff population nearly three-fold as part of any middle school consolidation
 - Replace student lockers
 - Add new student lockers
 - Add new student toilets
 - Add new staff toilets
 - New Gymnasium equipment
 - New locker rooms
 - Replace electrical system
 - Replace wood casework and millwork
 - Etc., etc., etc.
