Hardin Park

Assessment October 23, 2018

Project: ADA Assessment Greeneville TN

Building: Hardin Park Kiwanis Pavilion

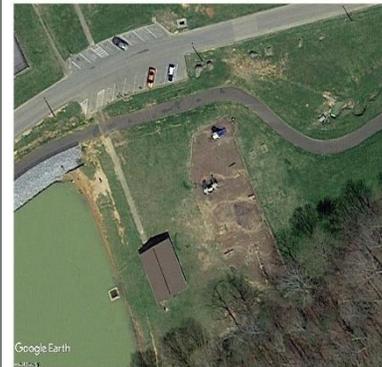
1.3 Of the accessible spaces, is at least one a van accessible space?*[208.2.4]

No

- Reconfigure by repainting lines

Budget Year: 2021 Cost: \$250
<p>1.4 Are accessible spaces at least 8 feet wide with an access aisle at least 5 feet wide? [502.2, 502.3]</p> <p>Note: Two spaces may share an access aisle. Check state/local requirements; some specify that each space have its own aisle.</p>	<p>Yes</p> <p>Measurement:</p>

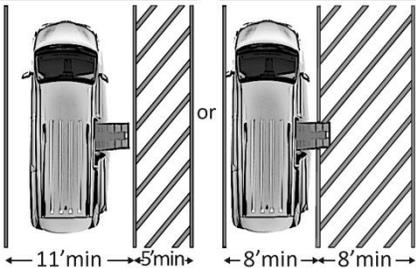
<p>← 8' min → 5' min →</p>	Photo #:	
<p>1.5 Is the van accessible space:</p> <p>At least 11 feet wide with an access aisle at least 5 feet wide? Or At least 8 feet wide with an access aisle at least 8 feet wide? [502.2]</p>	<p>No</p> <p>Measurement:</p> <p>No</p> <p>Measurement:</p>

<p>← 11' min → 5' min → or ← 8' min → 8' min →</p>	Photo #:	<ul style="list-style-type: none"> • Reconfigure to provide van-accessible space(s) • Re paint the lines <p>Budget Year: 2021 Cost: \$500</p>
<p>1.7 Are the access aisles marked so as to discourage parking in them? [502.3.3]</p> <p>Note: The marking method and color may be addressed by state/local requirements.</p>	<p>Yes</p>

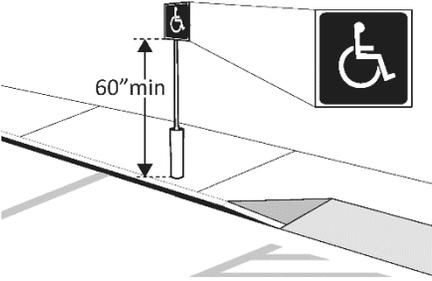
<p>Photo #:</p>	
<p>1.10 Are accessible spaces identified with a sign that includes the International Symbol of Accessibility? Is the bottom of the sign at least 60 inches above the ground? [502.6]</p> <p>Note: The International Symbol of Accessibility is not required on the ground.</p>	<p>No NA Measurement:</p>

<p>Photo #:</p>	<ul style="list-style-type: none"> • Install signs <p>Budget Year: 2020</p> <p>Cost: \$100</p>
<p>1.11 Are there signs reading “van accessible” at van accessible spaces? [502.6]</p>	<p>No</p>

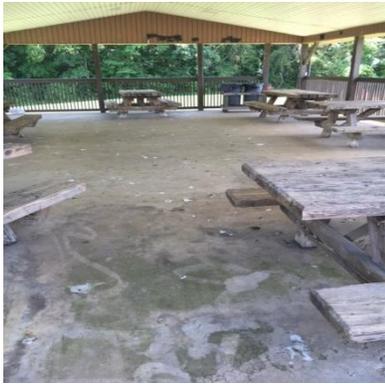
Are at least 5%, but no fewer than one, of seating and standing spaces accessible for people who use wheelchairs? [226.1]

No
 Total #:
 Wheelchair #: 0

- Provide accessible picnic tables
- Clean bird droppings out of pavilion

Budget Year: 2021

Cost: \$1,000
