ROBY FITZGERALD ADULT CENTER

ADA Checklist for Existing Facilities

Project: ADA Assessment Greeneville TN

Building: Roby Adult Center Basement

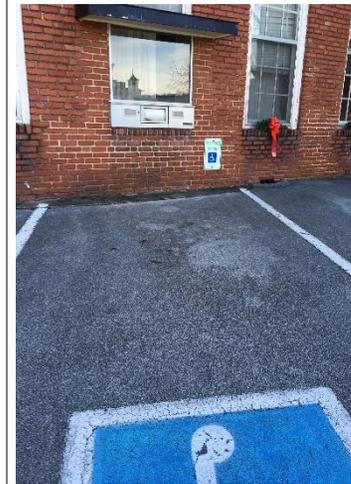
Photo #:

1.1 Is there at least one route from site arrival points (parking, passenger loading zones, public sidewalks and public transportation stops) that does not require the use of stairs?
[See 2010 ADA Standards for Accessible Design – 206.2.1]

Yes

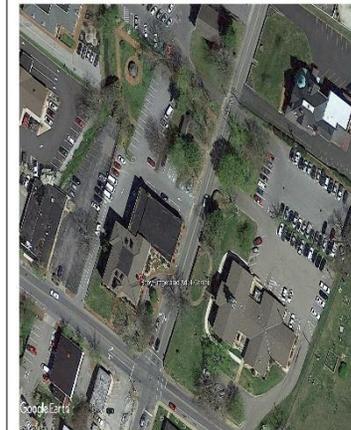
1.3 Of the accessible spaces, is at least one a van accessible space?*[208.2.4]

No

*For every 6 or fraction of 6 parking spaces required by the table above, at least 1 should be a van accessible space.

| | | | | <ul style="list-style-type: none"> • Reconfigure by repainting lines <p>Van Accessible Repaint</p> <p>Budget Year: 2020</p> <p>Cost: \$50</p> |

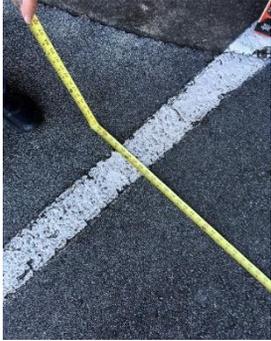
| <p>1.4 Are accessible spaces at least 8 feet wide with an access aisle at least 5 feet wide? [502.2, 502.3]</p> <p>Note: Two spaces may share an access aisle. Check state/local requirements; some specify that each space have its own aisle.</p> | <p>Yes</p> <p>Measurement: 9'-0"</p> <p>No aisle</p> | <p>← 8' min → 5' min →</p> | <p>Photo #:</p> | |

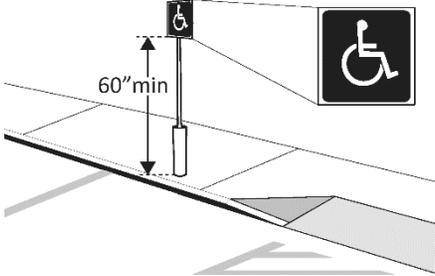
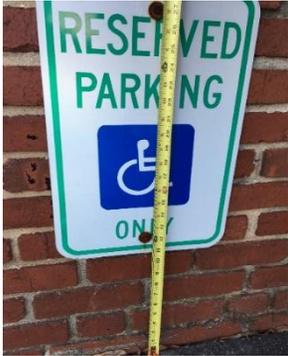
| <p>1.10 Are accessible spaces identified with a sign that includes the International Symbol of Accessibility? Is the bottom of the sign at least 60 inches above the ground? [502.6]</p> <p>Note: The International Symbol of Accessibility is not required on the ground.</p> | <p>Yes</p> <p>No</p> <p>Measurement: 12 inches</p> | | <p>Photo #:</p> | <ul style="list-style-type: none"> • Install signs <p>Budget Year: 2020</p> <p>Cost: \$50</p> |

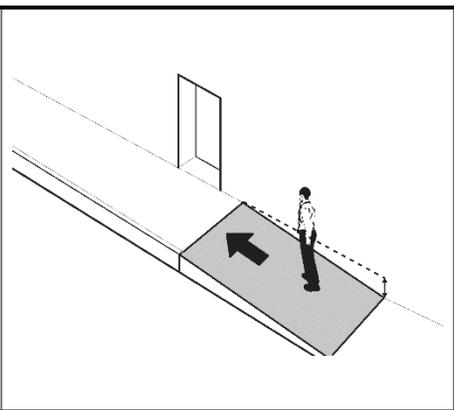
| <p>1.17 Is the running slope no steeper than 1:20, i.e. for every inch of height change there are at least 20 inches of route run? [403.3]</p> <p>Note: If the running slope is steeper than 1:20, treat as a ramp and add features such as edge protection and handrails.</p> | <p>Yes Measurement: ¼:12</p> | | <p>Photo #:</p> | |

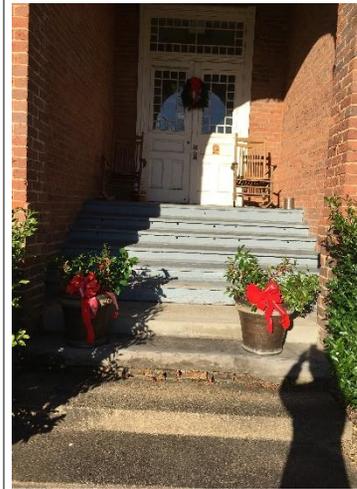
1.37 Is the main entrance accessible?

No

Install signage directing accessible entrance at 203 N. College St.

Budget Year: 2020

Cost: \$50

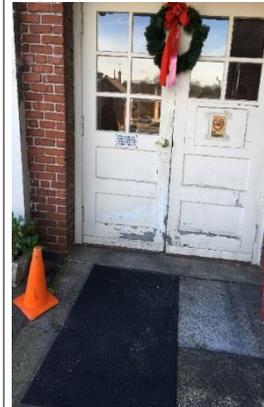
Photo #:

1.38 If the main entrance is not accessible, is there an alternative accessible entrance?

Yes

Can the alternative accessible entrance be used independently and during the same hours as the main entrance?

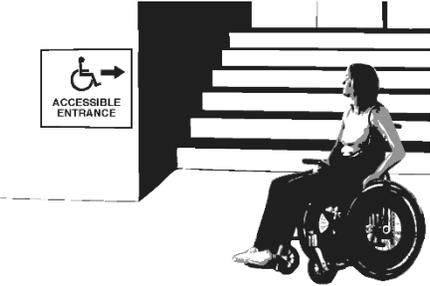
| <p>1.39 Do all inaccessible entrances have signs indicating the location of the nearest accessible entrance? [216.6]</p> | <p>No</p> | | <p>Photo #:</p> | <ul style="list-style-type: none"> • Install Signage <p>Refer to 1.37</p> |

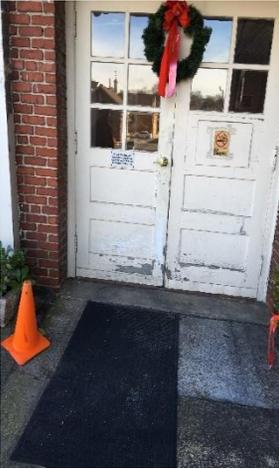
| <p>1.40 If not all entrances are accessible, is there a sign at the accessible entrance with the International Symbol of Accessibility? [216.6]</p> | <p>No</p> | | <p>Photo #:</p> | <ul style="list-style-type: none"> • Install sign <p>Refer to 1.37</p> |

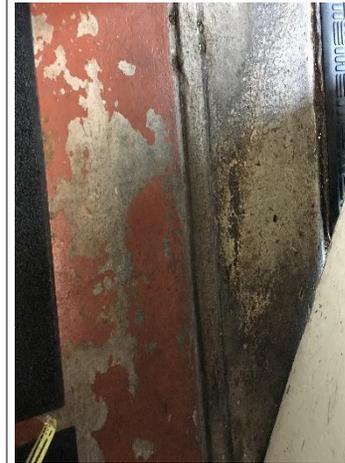
Photo #:

1.43 If the threshold is vertical is it no more than ¼ inch high?

Yes
Measurement:

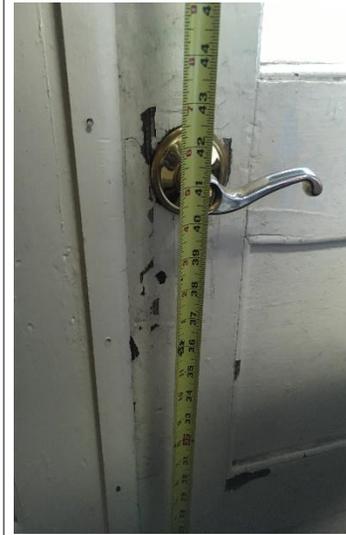
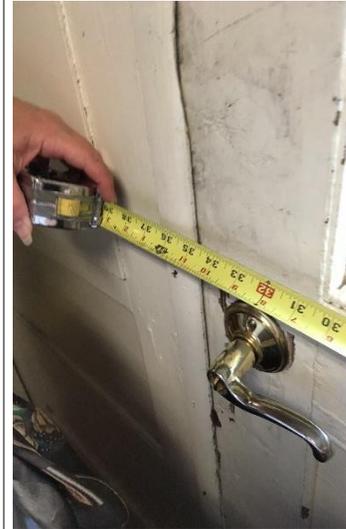
1.44 Is the door equipped with hardware that is operable with one hand and does not require tight grasping, pinching or twisting of the wrist?

No

Budget Year: 2020
Cost: \$40

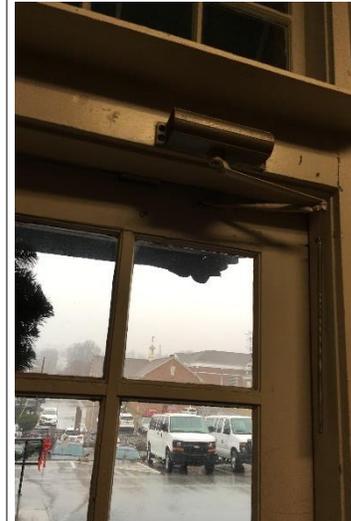
Photo #:

1.46 If the door has a closer, does it take at least 5 seconds to close from an open position of 90 degrees to a position of 12 degrees from the latch?
[404.2.8]

Yes
Measurement:

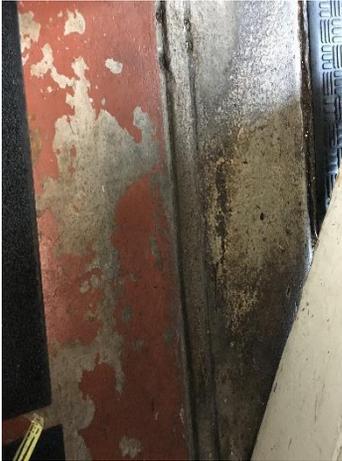
| <p>1.48 If provided at the building entrance, are carpets or mats no higher than ½ inch thick? [302.2]</p> | <p>Yes</p> <p>Measurement:</p> | | <p>Photo #:</p> | |

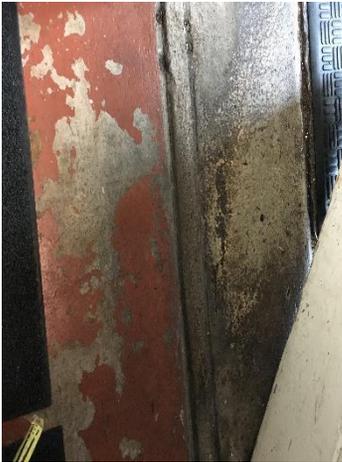
| <p>1.49 Are edges of carpets or mats securely attached to minimize tripping hazards? [302.2]</p> | <p>No</p> | | | <ul style="list-style-type: none"> • Secure carpeting or mats at edges <p>Budget Year: 2020</p> <p>Cost: \$120</p> |

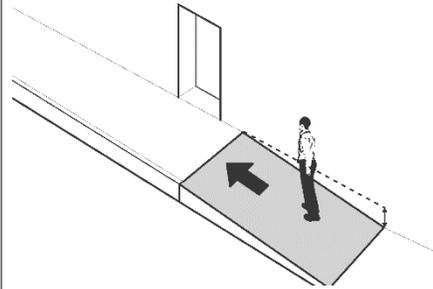
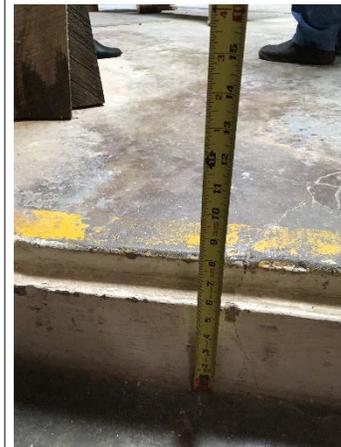
2.6 Is the running slope no steeper than 1:20, i.e. for every inch of height change there are at least 20 inches of route run?
[403.3]

No

Measurement:
8 inches

- Add ramp
- Budget Year: 2021
Cost: \$200

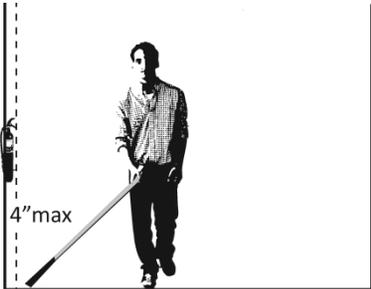
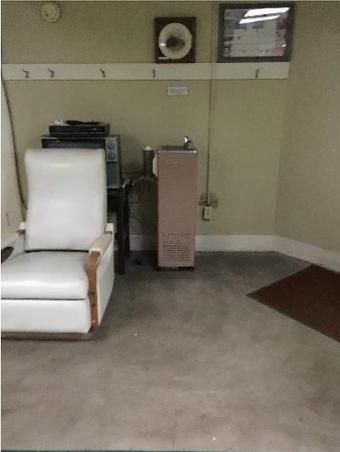
| <p>2.8 Do all objects on circulation paths through public areas, e.g. fire extinguishers, drinking fountains, signs, etc., protrude no more than 4 inches into the path? Or If an object protrudes more than 4 inches, is the bottom leading edge at 27 inches or lower above the floor? [307.2]</p> | <p>No Measurement: NA Measurement:</p> | <p>Or</p> | | <ul style="list-style-type: none"> • Add tactile warning such as permanent planter or partial walls <p>Budget Year: 2022 Cost: \$100</p> |

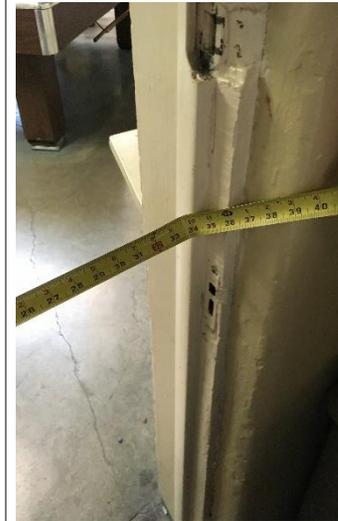
Photo #:

2.40 Is the door opening width at least 32 inches clear, between the face of the door and the stop, when the door is open 90 degrees?
[404.2.3]

Yes
Measurement:
34 inches

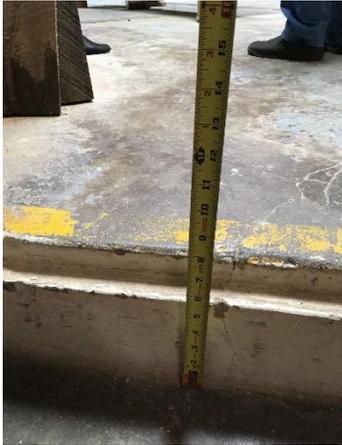
On both sides of the door, is the floor surface of the maneuvering clearance level (no steeper than 1:48)?
[404.2.4]

No
Measurement:

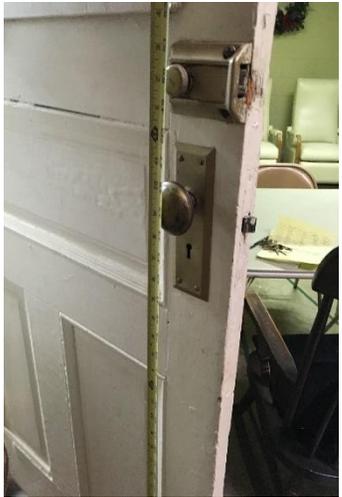
| <p>2.43 Is the door equipped with hardware that is operable with one hand and does not require tight grasping, pinching or twisting of the wrist?</p> <p>Door handle? No</p> <p>Lock (if provided)? No</p> <p>[404.2.7]</p> | <p>No</p> <p>No</p> <p>No</p> | | <p>Photo #:</p> | <ul style="list-style-type: none"> • Replace inaccessible knob with lever, loop or push hardware • Add automatic door opener <p>Budget Year: 2020</p> <p>Cost: \$850</p> |

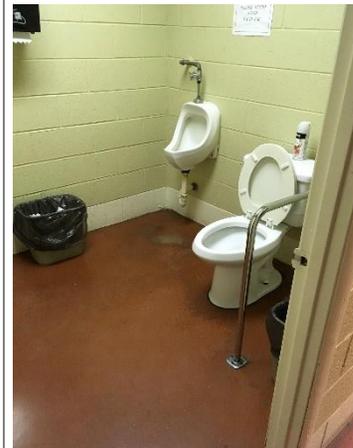
3.1 If toilet rooms are available to the public, is at least one toilet room accessible? (Either one for each sex, or one unisex.)

No

- Reconfigure toilet rooms
- Combine toilet rooms to create one unisex accessible toilet room

Budget Year: 2023

Cost: \$2,000

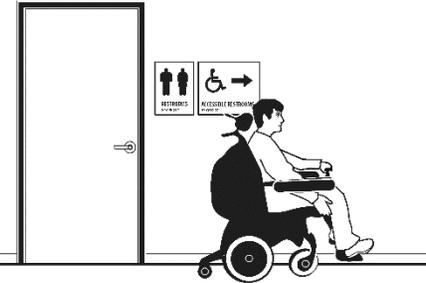
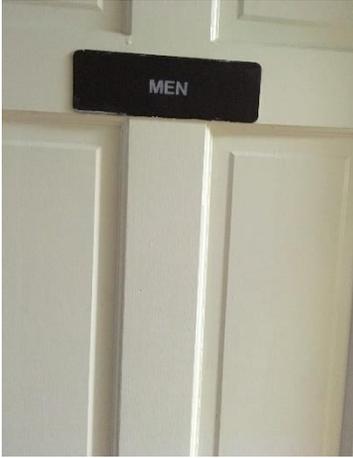
| <p>3.2 Are there signs at inaccessible toilet rooms that give directions to accessible toilet rooms? [See 2010 ADA Standards for Accessible Design – 216.8]</p> | <p>No</p> | | | <ul style="list-style-type: none"> • Install signs <p>Budget Year: 2020</p> <p>Cost \$50</p> |

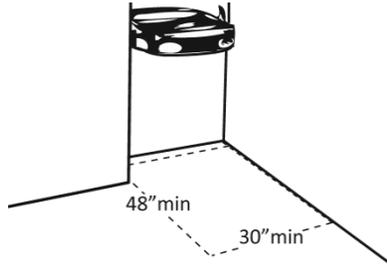
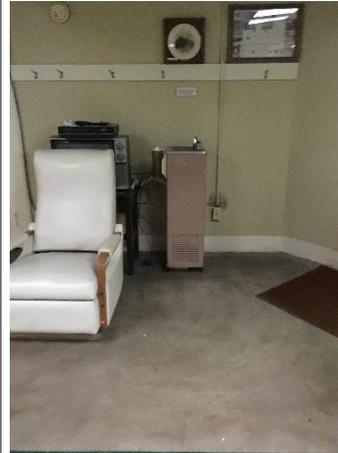
4.1 Does at least one drinking fountain have a clear floor space at least 30 inches wide x at least 48 inches long centered in front of it for a forward approach?*

No
Measurement:

Refer to 4.2

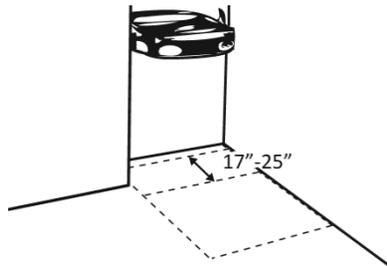
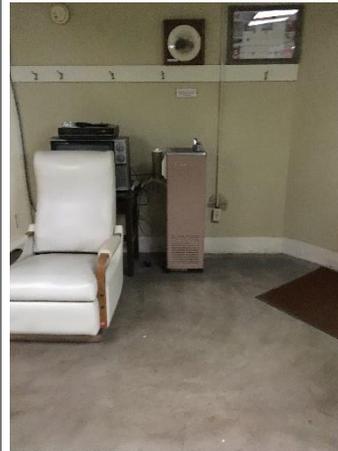
4.2 If there is a forward approach, do no less than 17 inches and no greater than 25 inches of the clear floor space extend under the drinking fountain?

No
Measurement:

- Replace drinking fountain with water coolers

Budget Year: 2021

Cost \$500
