HAMPDEN-WILBRAHAM REGIONAL SCHOOL DISTRICT
EXISTING CONDITIONS and FEASIBILITY STUDY
THORTON W. BURGESS and WILBRAHAM MIDDLE SCHOOL

WILBRAHAM MIDDLE SCHOOL

Hampden-Wilbraham Regional School District
Middle School Study ~ 2 September 2015

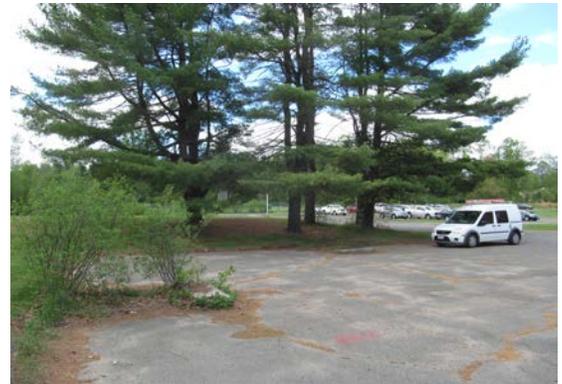
The existing Middle School access drive and parking areas are original to the site and are in very poor condition, with significant areas of deteriorated, damaged and/or missing asphalt paving and curbs.

If the status of WMS is maintained as a single middle school serving the Town of Wilbraham, the existing asphalt access drive except the newly widened area at Stony Hill Road, parking lot and curbing, and storm drainage structures are deteriorated beyond repair and should be removed and replaced in their entirety as budgets allow. Existing playfields require minimal repair except for normal wear and tear.
