HAMPDEN-WILBRAHAM REGIONAL SCHOOL DISTRICT
EXISTING CONDITIONS and FEASIBILITY STUDY
THORNTON W. BURGESS and WILBRAHAM MIDDLE SCHOOL

THORNTON W. BURGESS MIDDLE SCHOOL

SITE EVALUATION

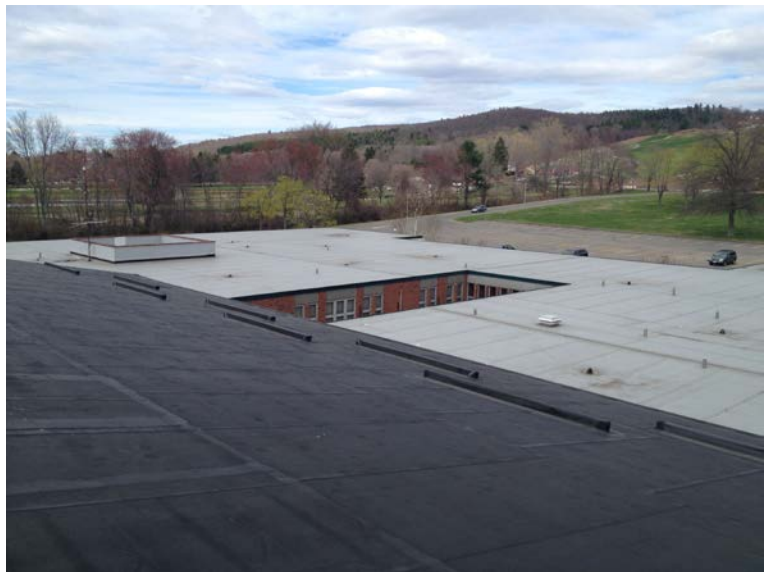
The existing building utilizes two separate roof systems. Pitched to drain areas are covered with a single-ply, polyvinyl chloride (PVC) membrane, with copper counter and cap flashing at roof-to-wall and penetration locations, and aluminum fascia. Sloped roofs at the Cafetorium and Gymnasium are covered with single ply EPDM (rubber) membrane. Individual roof areas are drained via four (4) inch roof drains at selected locations.

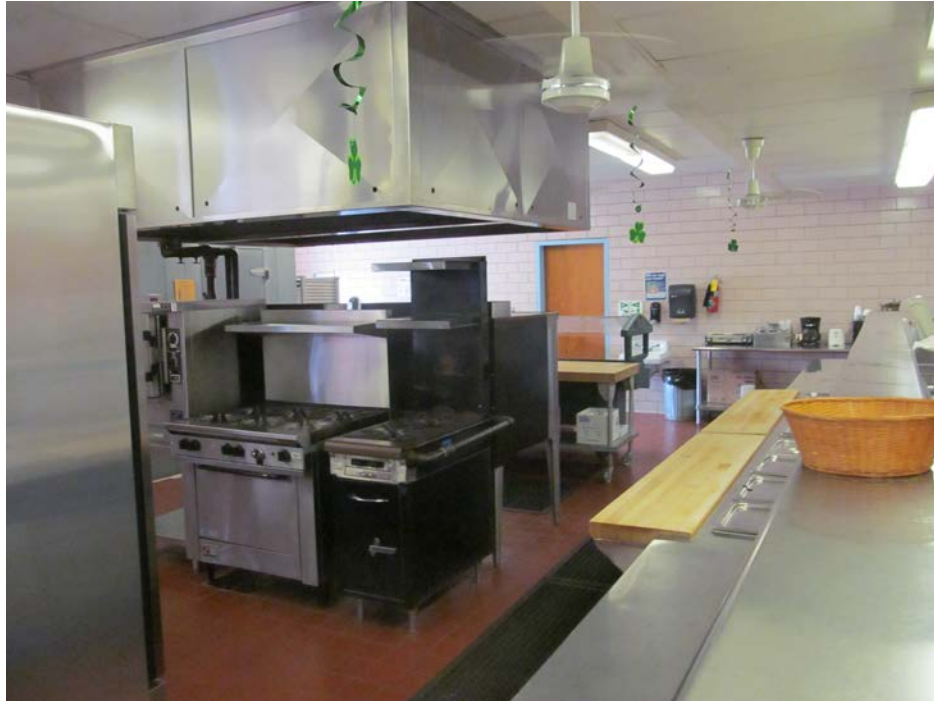
Existing food service equipment is industry standard, stainless steel, electric and low pressure natural gas fired, and in overall good condition with no reported malfunctioning equipment. The Kitchen prepares and serves lunch during four (4) servings. See the Mechanical Section of this Report for detailed evaluation of the kitchen exhaust hood, and related mechanical, plumbing and electrical systems.

The existing food service equipment is in overall excellent condition, well maintained, and subject to ongoing repairs and replacement. See the Mechanical Section of this Report for detailed evaluation of the kitchen exhaust hood, and related mechanical, plumbing, electrical and life safety systems. See the Mechanical Section of this Report for detailed evaluation of the kitchen exhaust hood, and related mechanical, plumbing, electrical and life safety systems.
