**Hardin Park
High School Baseball – Softball Field**

Assessment October 23, 2018

Project: ADA Assessment Greeneville, TN

Building: High School Baseball/Softball Fields
And Noon Rotary Club Field

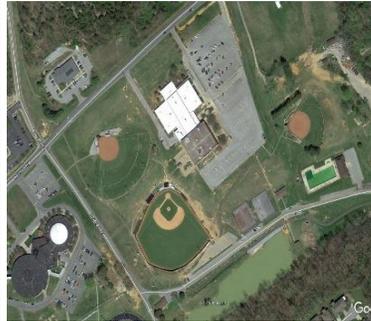
Priority 1 – Approach & Entrance		Comments	Possible Solutions
<p>1.1 Is there at least one route from site arrival points (parking, passenger loading zones, public sidewalks and public transportation stops) that does not require the use of stairs? [See 2010 ADA Standards for Accessible Design – 206.2.1]</p>	<p>No accessible route No accessible parking</p>

<p>Photo #:</p>	<ul style="list-style-type: none"> • Design access • Design accessible parking <p>Budget Year: 2020 Cost: \$12,500</p>
Exterior Accessible Route			
<p>1.13 Is the route stable, firm and slip-resistant? [302.1]</p>	<p>No accessible route</p>

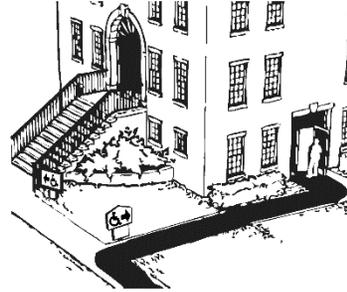
1.38 If the main entrance is not accessible, is there an alternative accessible entrance?

No

- Designate an entrance and make it accessible
- Refer to 1.13

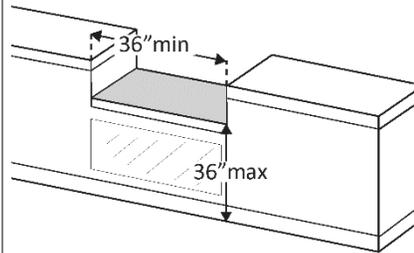
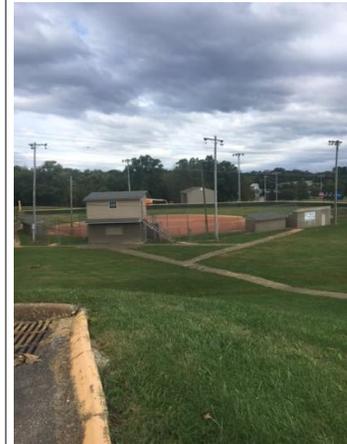
2.76 Is there a portion of at least one of each type of counter that is:

No higher than 36 inches above the floor?

At least 36 inches long?
[904.4.1]

No
Measurement:

- Lower section of counter

Budget Year: 2020
Cost: \$1,000
