**Hardin Park
Optimist Field**

Assessment October 23, 2018

ADA Checklist for Existing Facilities

Project: ADA Assessment Greenville TN

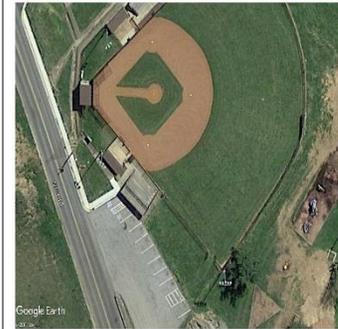
Photo #:

1.1 Is there at least one route from site arrival points (parking, passenger loading zones, public sidewalks and public transportation stops) that does not require the use of stairs? [See 2010 ADA Standards for Accessible Design – 206.2.1]

Yes

If yes, location of route:

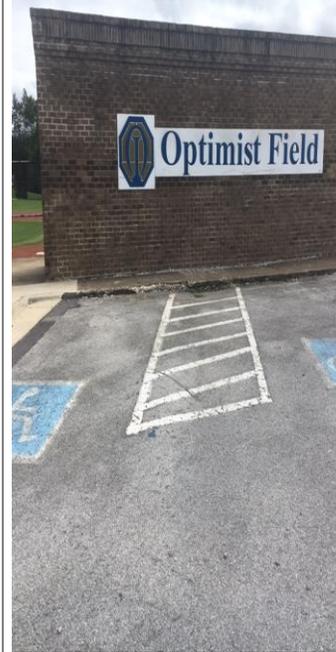
Photo #:

1.4 Are accessible spaces at least 8 feet wide with an access aisle at least 5 feet wide?
[502.2, 502.3]

Yes
Measurement:

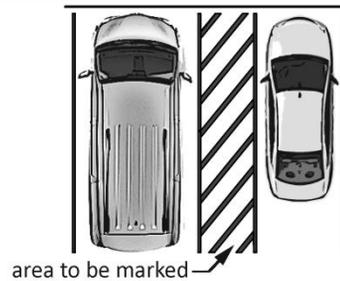
Photo #:

1.7 Are the access aisles marked so as to discourage parking in them?
[502.3.3]

Yes

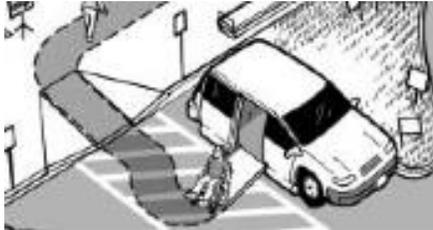
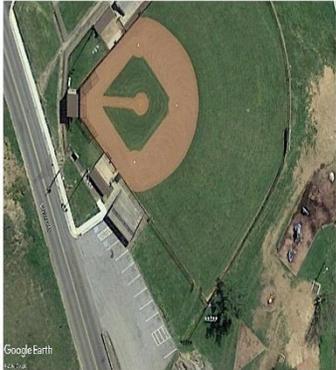
Photo #:	
<p>1.9 Do the access aisles adjoin an accessible route? [502.3]</p>	No

<ul style="list-style-type: none"> • Create accessible route • Relocate accessible space • Do sidewalk work to be able to complete <p>Budget Year: 2023</p> <p>Cost: \$7,500</p> <p>Also See 1.30</p>
<p>1.10 Are accessible spaces identified with a sign that includes the International Symbol of Accessibility? Is the bottom of the sign at least 60 inches above the ground? [502.6]</p> <p>Note: The International Symbol of Accessibility is not required on the ground.</p>	No NA Measurement:

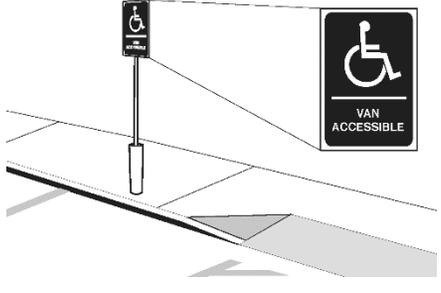
<p>1.11 Are there signs reading “van accessible” at van accessible spaces? [502.6]</p>	<p>No</p>

<p>Photo #:</p>	<ul style="list-style-type: none"> • Install signs <p>Budget Year: 2020</p> <p>Cost; \$100</p>
<p>1.12 Of the total parking spaces, are the accessible spaces located on the closest accessible route to the accessible entrance(s)? [208.3.1]</p> <p>Note: If parking serves multiple entrances, accessible parking should be dispersed.</p>	<p>Yes</p>		<p>Photo #:</p>	
<p>Exterior Accessible Route</p>				
<p>1.13 Is the route stable, firm and slip-resistant? [302.1]</p>	<p>Yes</p>		<p>Photo #:</p>

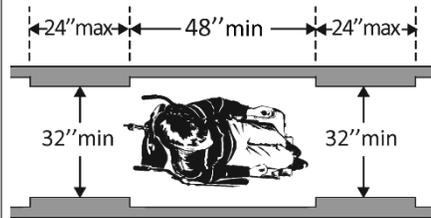
Photo #:

1.14 Is the route at least 36 inches wide?
[403.5.1]

Yes
Measurement:

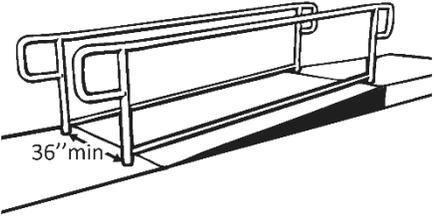
<p>1.25 If there is a ramp is it at least 36 inches wide? [405.5]</p> <p>Note: If there are handrails, measure between the handrails.</p>	<p>Yes</p> <p>Measurement:</p>

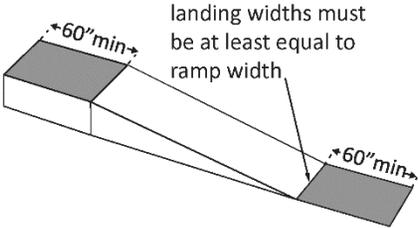
<p>Photo #:</p>	
<p>1.28 Is there a level landing that is at least 60 inches long and at least as wide as the ramp: At the top of the ramp?</p>	<p>Yes</p> <p>Measurement:</p>

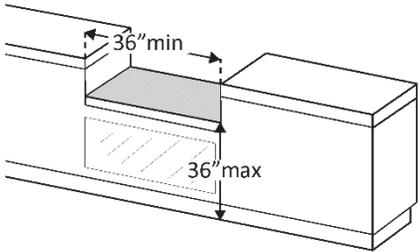
<p>2.76 Is there a portion of at least one of each type of counter that is:</p> <p>No higher than 36 inches above the floor?</p> <p>At least 36 inches long? [904.4.1]</p>	<p>No Measurement: 42"</p> <p>Yes Measurement: 48"</p>

<p>Photo #:</p>	<ul style="list-style-type: none"> • Lower section of counter • Add roll up door to match <p>Budget Year: 2024</p> <p>Cost: \$750</p>
<p>2.79 For a parallel approach, is the clear floor space positioned with the 48 inches adjacent to the accessible length of counter? [904.4.1]</p>	<p>Yes</p> <p>Too much slope at counter</p>
